ARCONIC ARCHITECTURAL PRODUCTS FIRE TEST REPORT

CAN/ULC S134, STANDARD METHOD OF FIRE TESTS OF EXTERIOR WALL ASSEMBLIES
CONTAINING ARCONIC REYNOBOND[®] RB-160-FB

103413434SAT-003

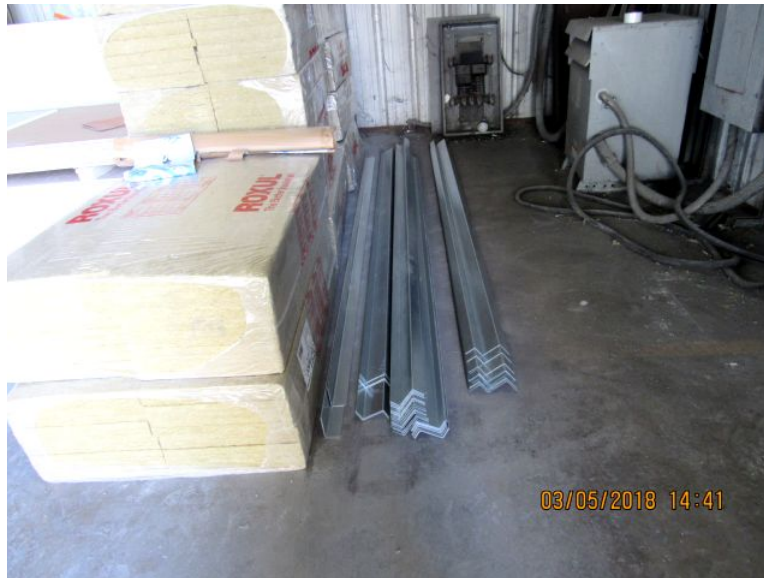
Collection of All Girts, Closure Angles, and Flashing

Closure angle pieces consisting of 16 GA stair step zee girts were installed vertically from the base of the floor to the top edge of the base wall. The girt profile consisted of a horizontal leg at 5.4 cm, a vertical leg at 7.5 cm, a second horizontal leg at 4.3 cm and a second vertical leg at 4.3 cm. The overall girt was 9.7 cm in width and 11.8 cm in height. Holes were pre-drilled in the 5.4 cm horizontal leg at 0.5 cm diameter, 40.6 cm on-center (oc) nominally, beginning at 15 cm from the edge. The closure girts were secured with 7 cm long x .65 cm diameter concrete anchor screws through the pre-drilled holes. The closure zeers were set 5 m apart, oc, and oriented so that the closure angles were wider apart as they extended from the base wall surface (see photos), or that the lip/plane furthest from the wall was closer to the vertical edge/perimeter of the base wall.

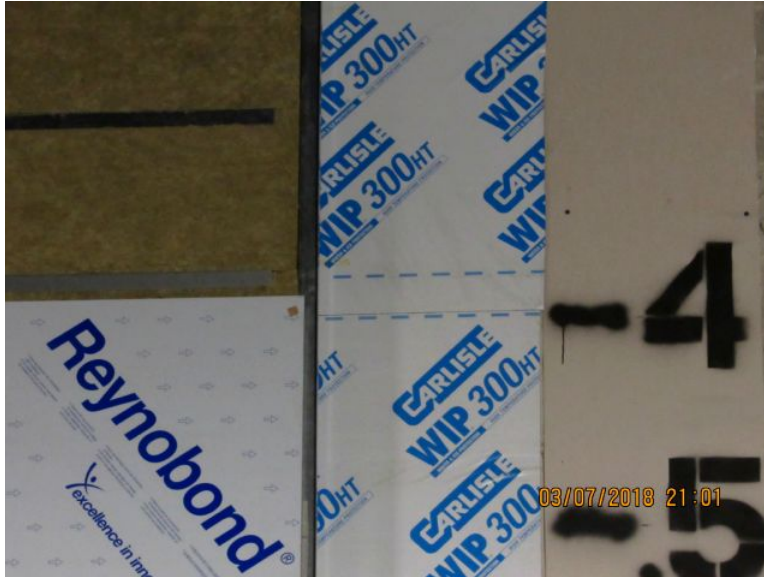
Panels Installed on Clip Not Fastened to Respective Girt

Please note, the zee girt row located 4m above the window opening was not aligned per the drawing. The clip was instead fastened to the vertical clips and through the insulation.

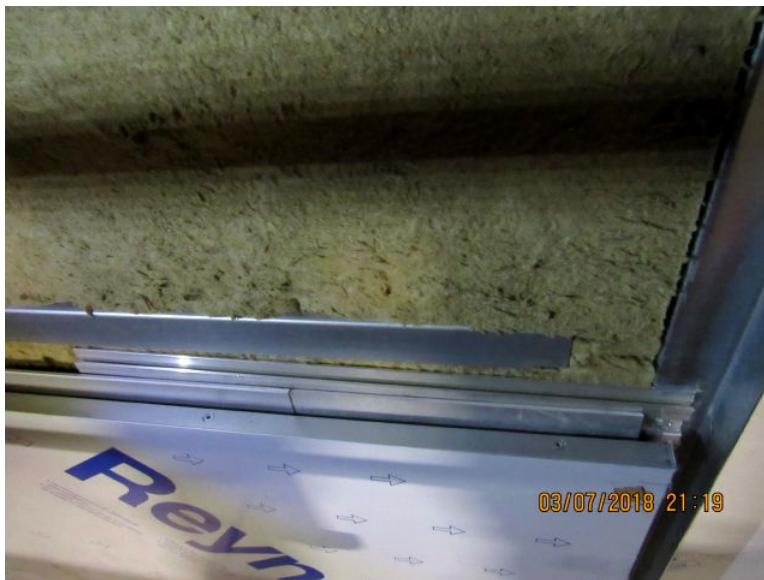
Closer View of Abnormal Clip Install

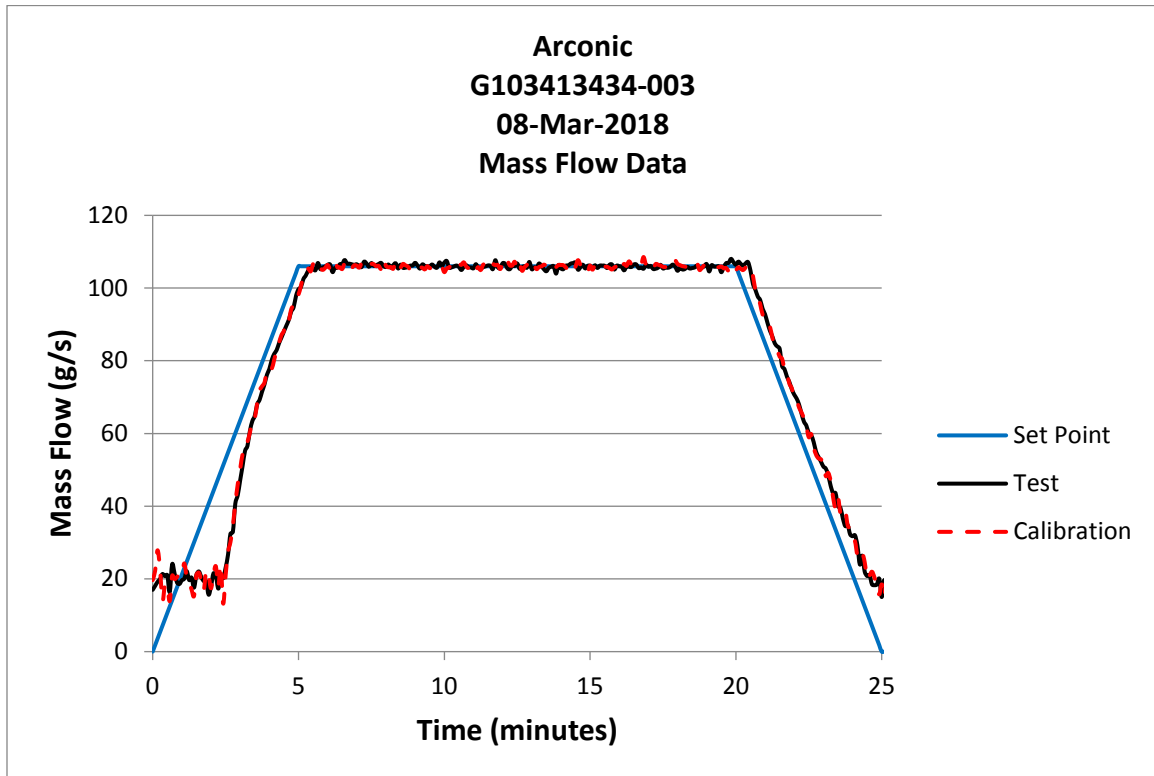
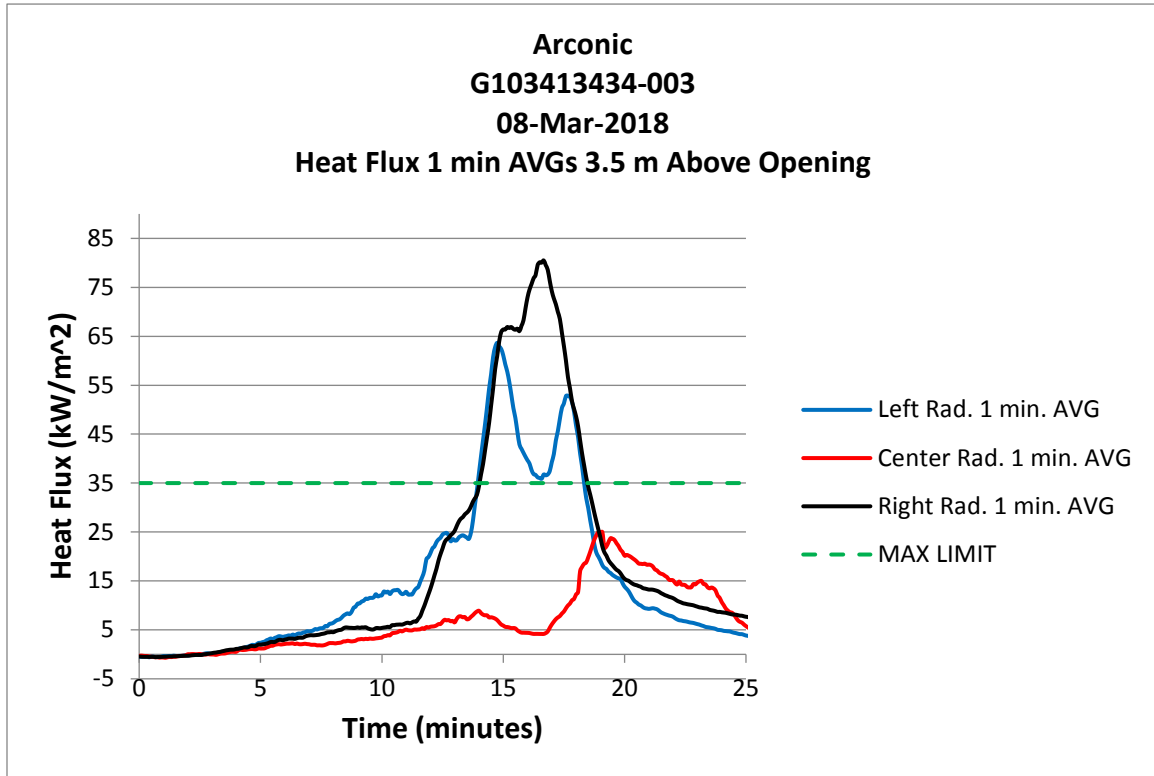
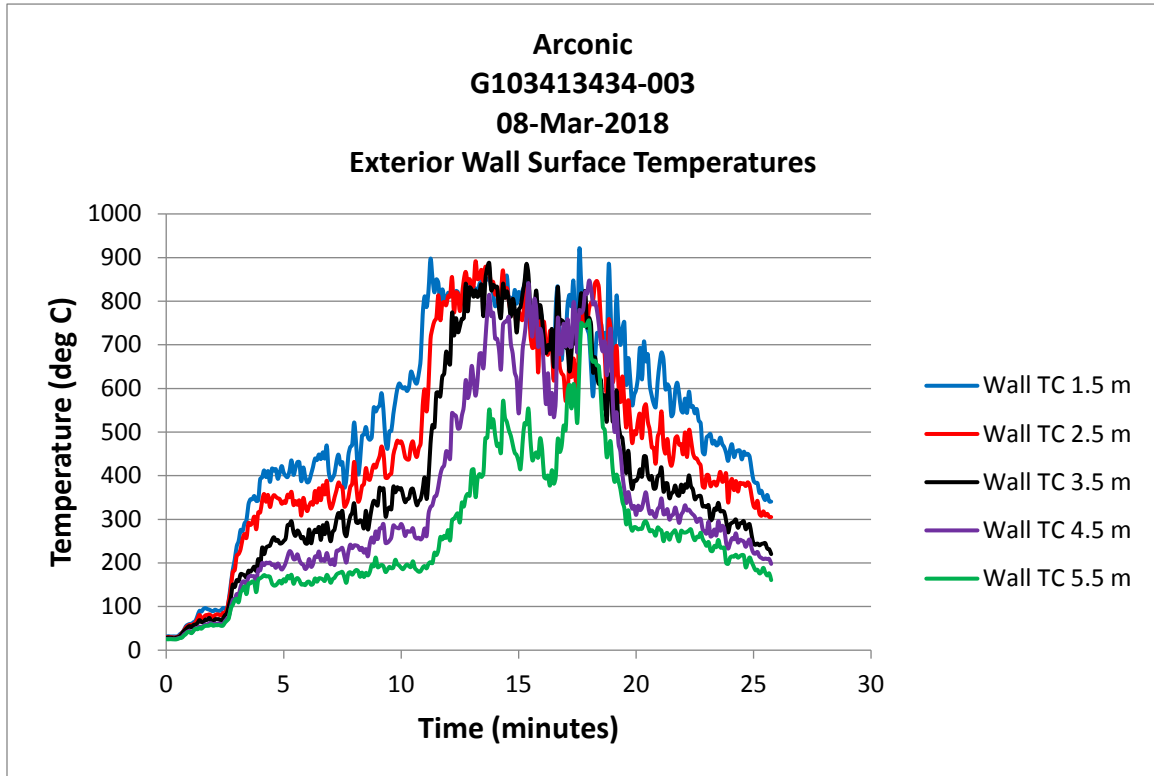
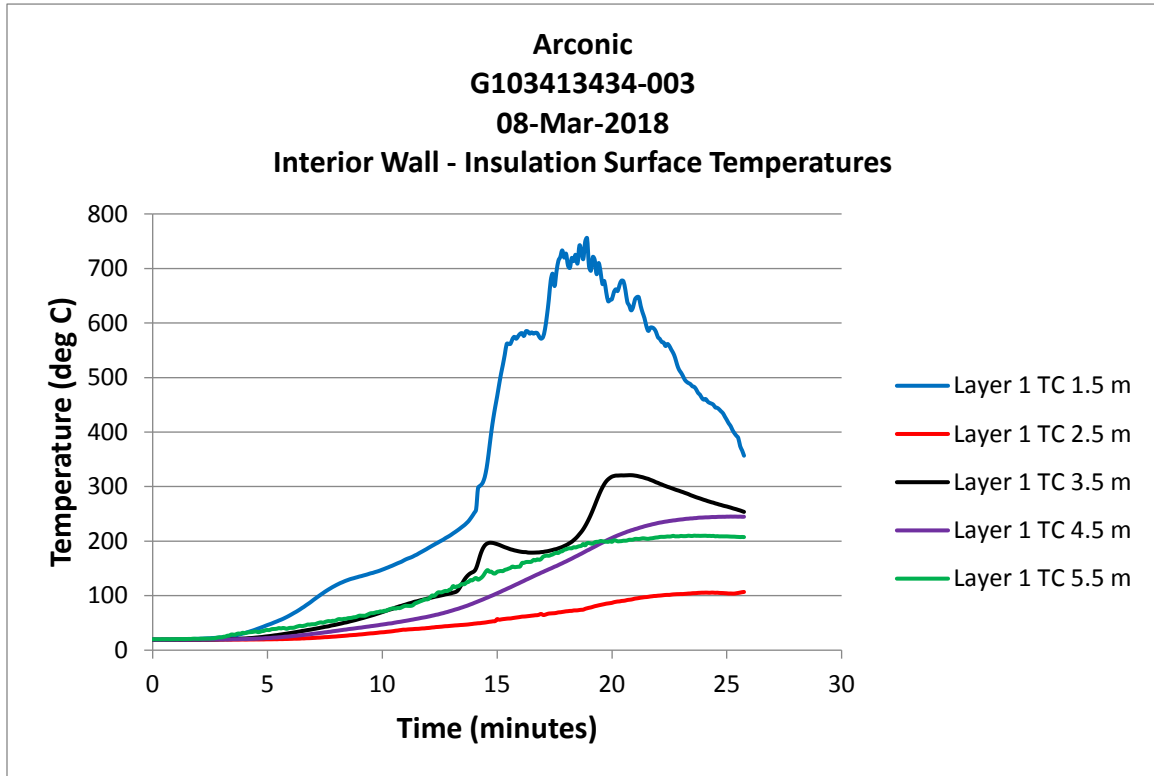
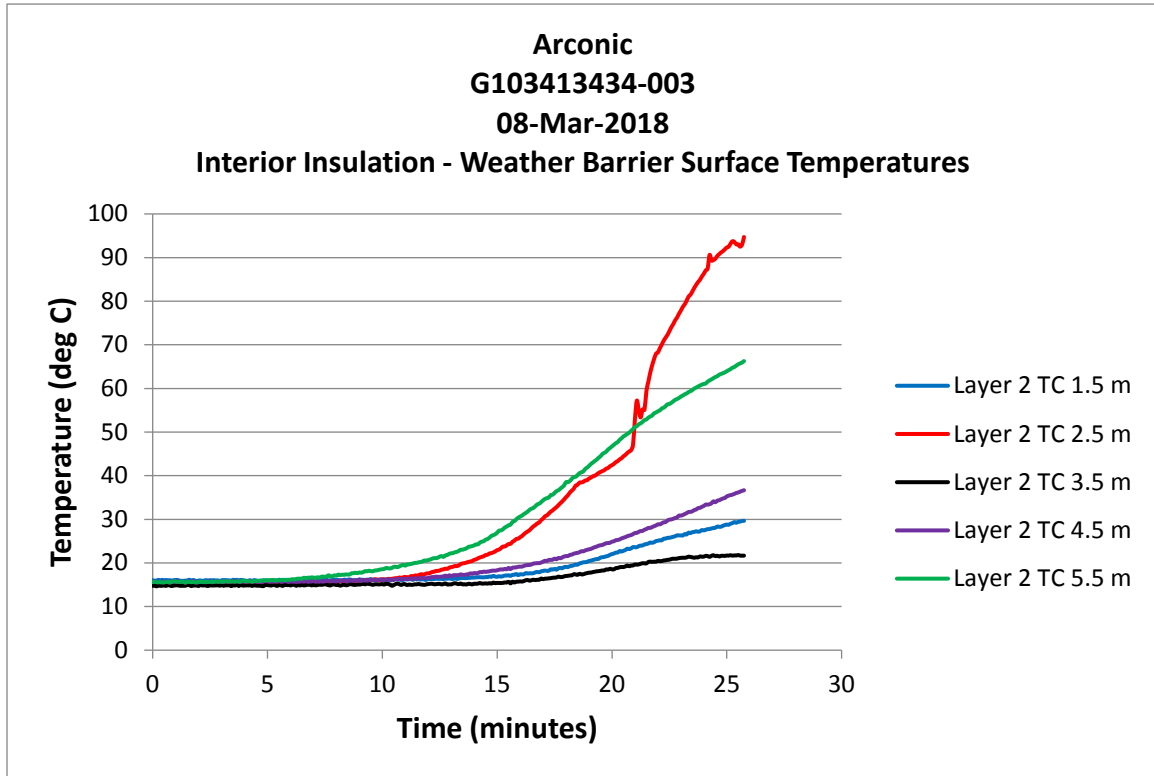
GRAPHS

The output of the transducers and thermocouples were monitored by a National Instruments CDAQ-9188 Data Acquisition Unit. The data acquisition system was programmed to scan and save data every 5 seconds. Following the test, the files were imported into MS Excel for tabular and graphical display. The graphical display data can be found in Section 13.

Time (min)	Left Radiometer (1 min. Avg.)	Right Radiometer (1 min. Avg.)	Center Radiometer (1 min. Avg.)	Visual Flame Height (in meters)
0:00	-0.43743	-0.43978	-0.30736	0

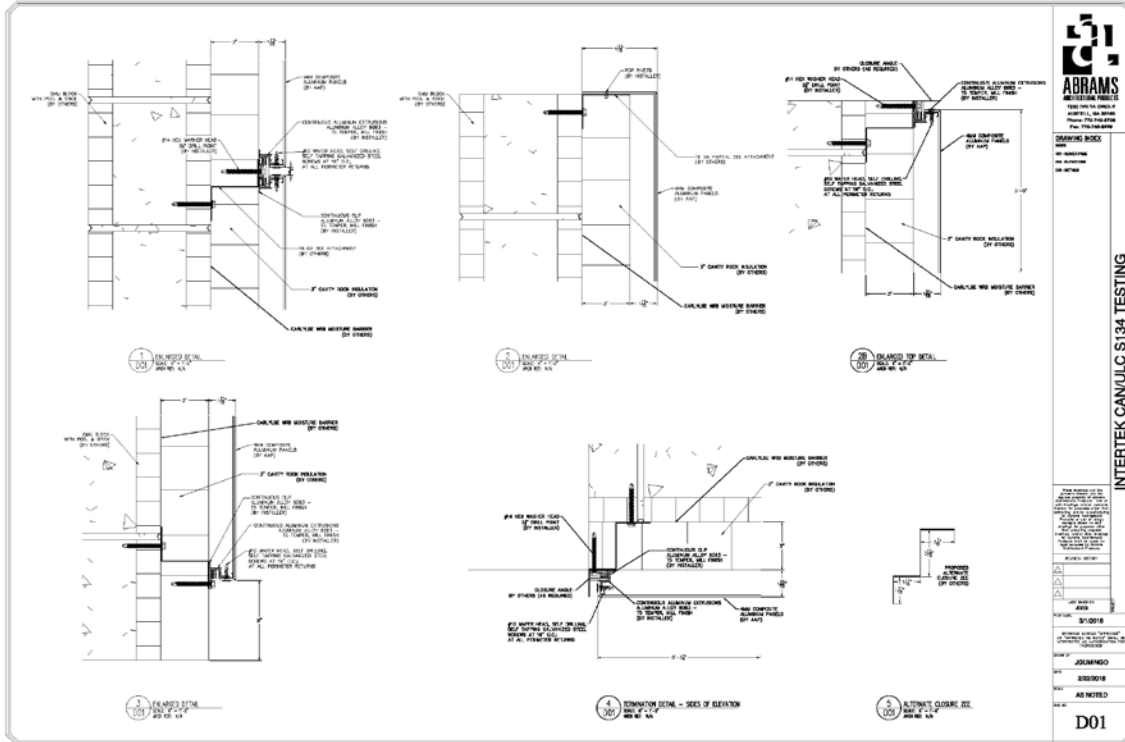
The "As-Built" drawings which follow have been reviewed by Intertek B&C and are representative of the project reported herein. Project construction was verified by Intertek B&C per the drawings included in this report. Any deviations are documented herein or on the drawings.
