ARCONIC ARCHITECTURAL PRODUCTS FIRE TEST REPORT

CAN/ULC S134, STANDARD METHOD OF FIRE TESTS OF EXTERIOR WALL ASSEMBLIES

104231720SAT-001

TEST REPORT FOR ARCONIC ARCHITECTURAL PRODUCTS

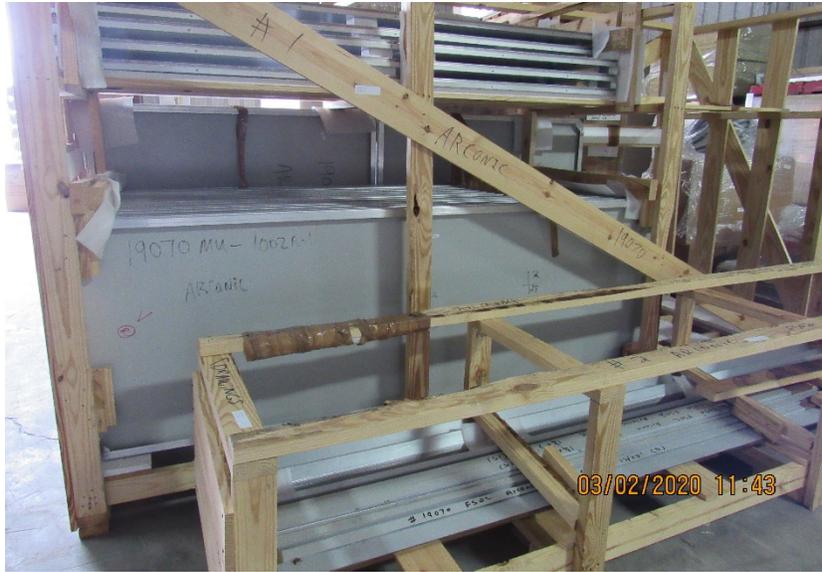
Photo No. 1
Panels received

The components of the 3mm Pre-painted Bonded Sheet AS3000B panels were witnessed in construction by Intertek inspector Ronald Cole at the Arconic Facility in Eastman, GA USA on November 19, 2019. Intertek verified the composition, manufacturing techniques, and quality assurance procedures for the samples. The witnessing and sampling is documented in Intertek Sampling Report K3682.03-103-15. The samples were received at the Evaluation Center on 03/02/20 in good condition and were assigned Intertek Sample ID No. SAT2003021029-001.

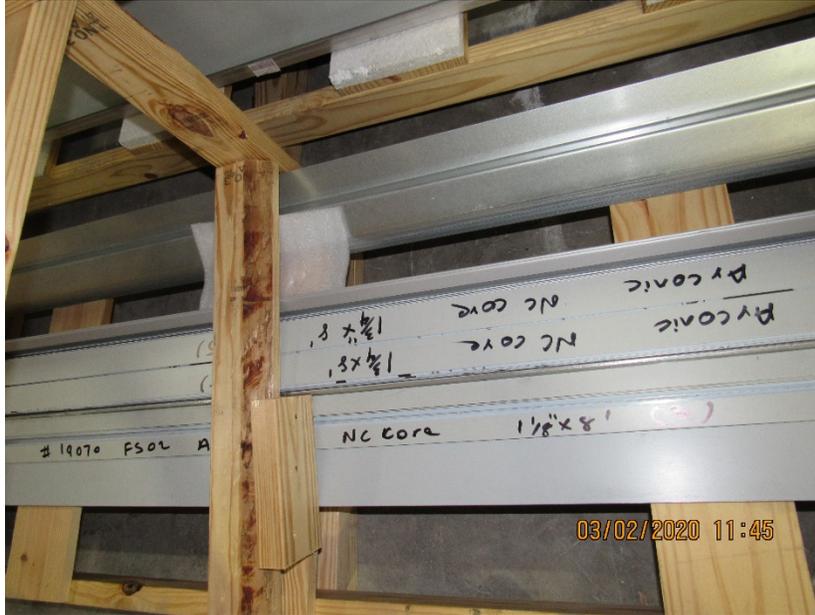
Photo No. 5
Steel zees and flashing

WrapShield SA[®] vapor barrier was applied to the surface of the gypsum sheathing. 16GA, 2 in. galvanized zee clips were then installed to the weather barrier using #14 x 1-3/4 in. Tapcon concrete fasteners, spaced at nominal 21.5 in. oc. 2 in. mineral wool insulation was then installed between the zee clips, having a density of 4.3 pcf.

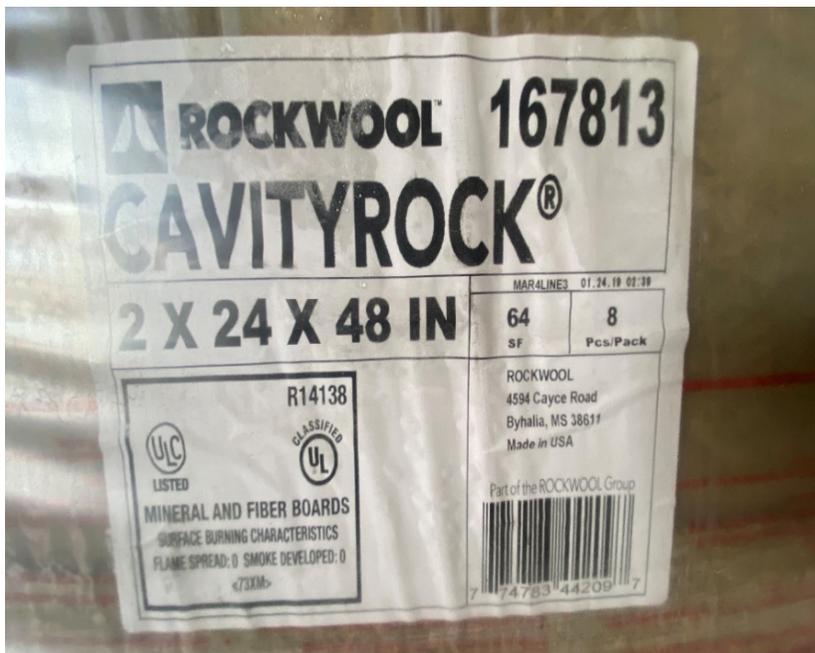
Photo No. 6
Insulation

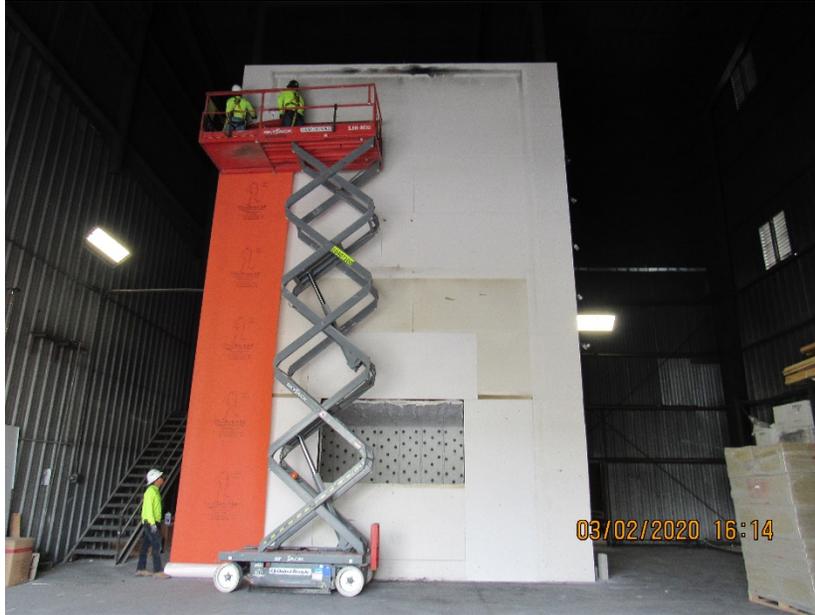
Photo No. 7
Installation of WRB

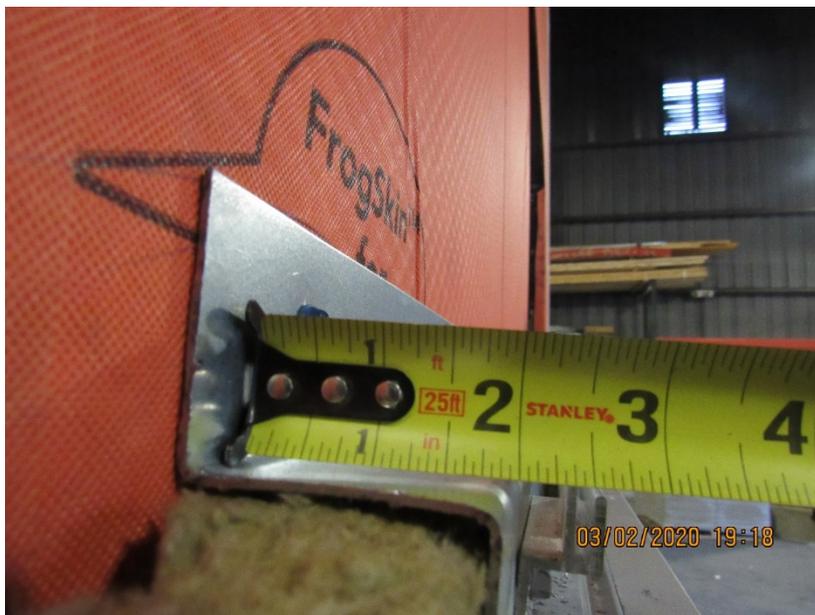
Photo No. 8
Steel Zee Installation

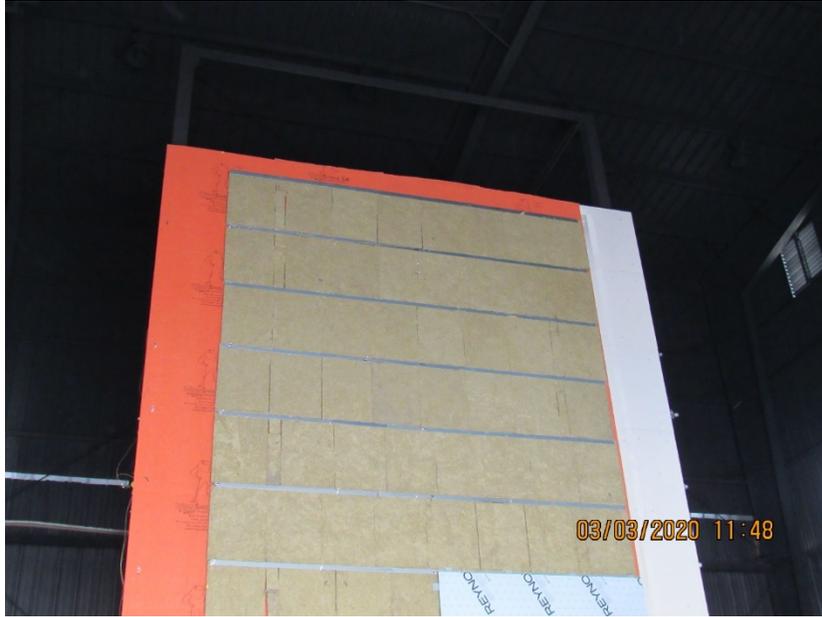
Photo No. 9
Insulation installed

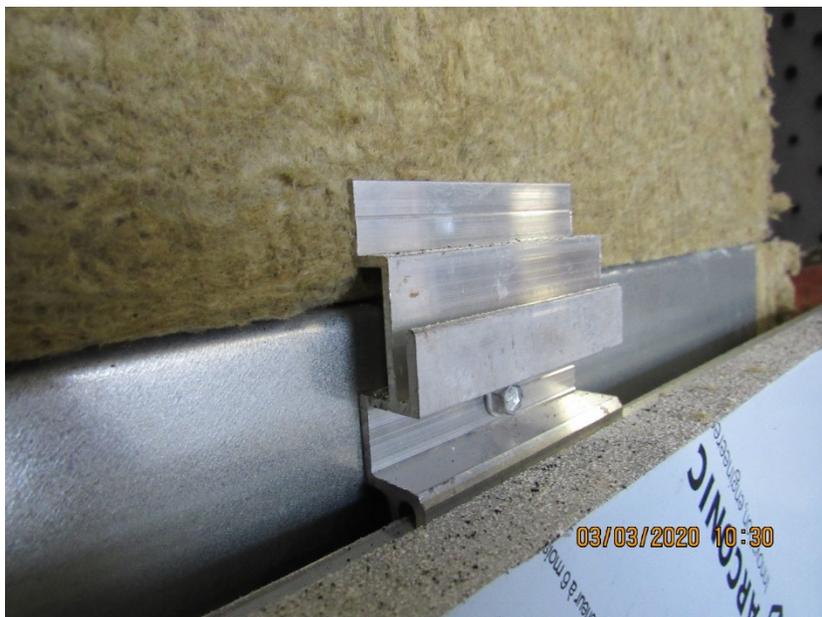
Photo No. 10
Panel Installation

The 3mm Pre-painted Bonded Sheet AS3000B ACM panels were installed to the wall assembly using 3 in. wide aluminium extrusions clips, spaced at nominal 36 in. oc, attached using #12 x 1 in. Tek2 fasteners.

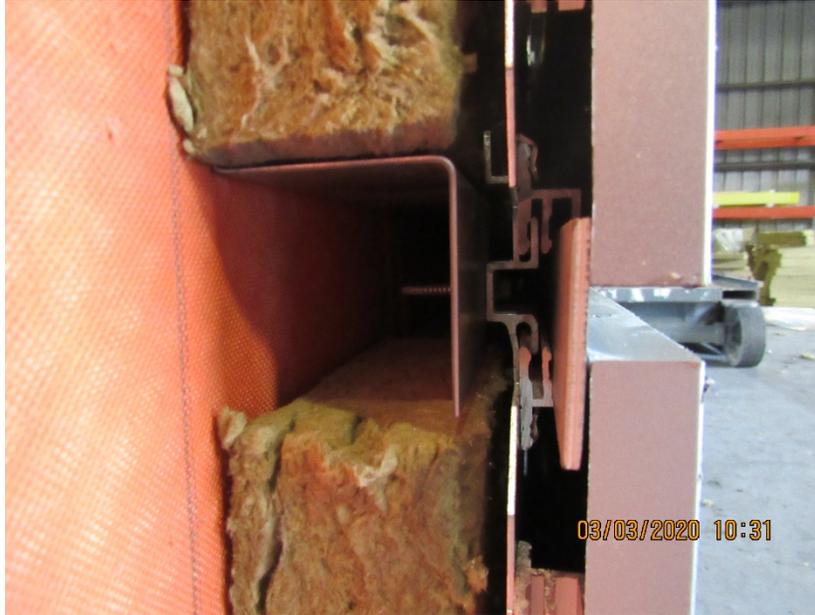
Photo No. 11
Horizontal Joint View

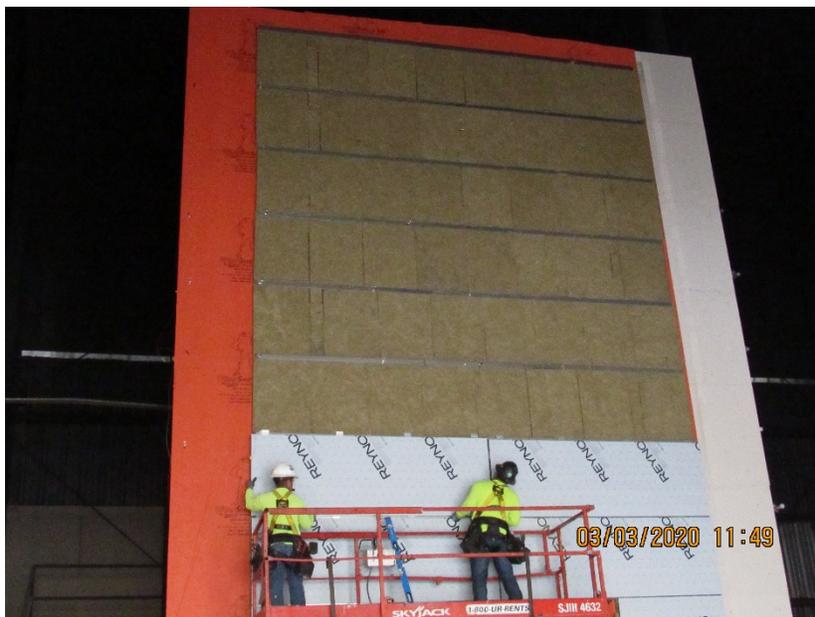
Photo No. 12
Panel Assembly

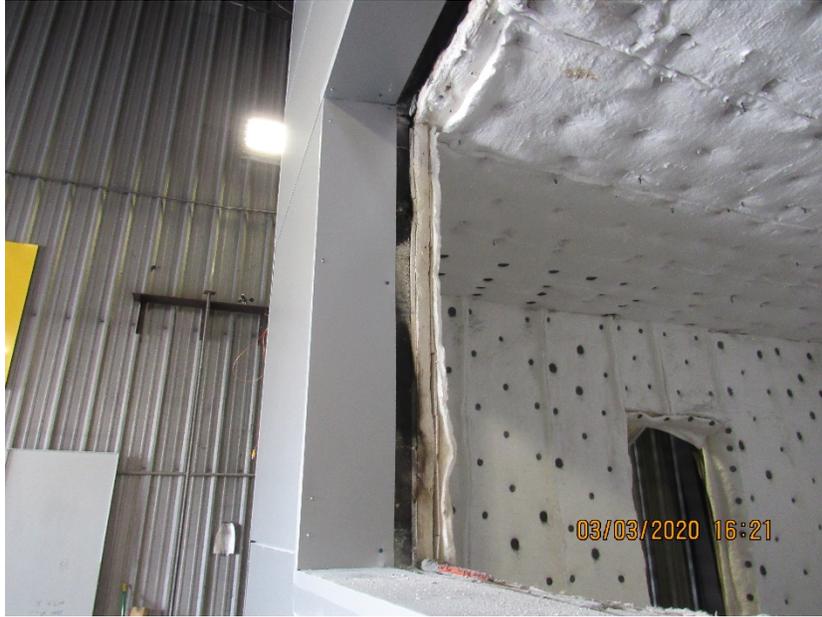
Photo No. 13
Window opening

The window opening jambs, sill and header were lined with .040 in. thick aluminum flashing, width of 4 in. This flashing was also used to seal the sides and top of the wall assembly.

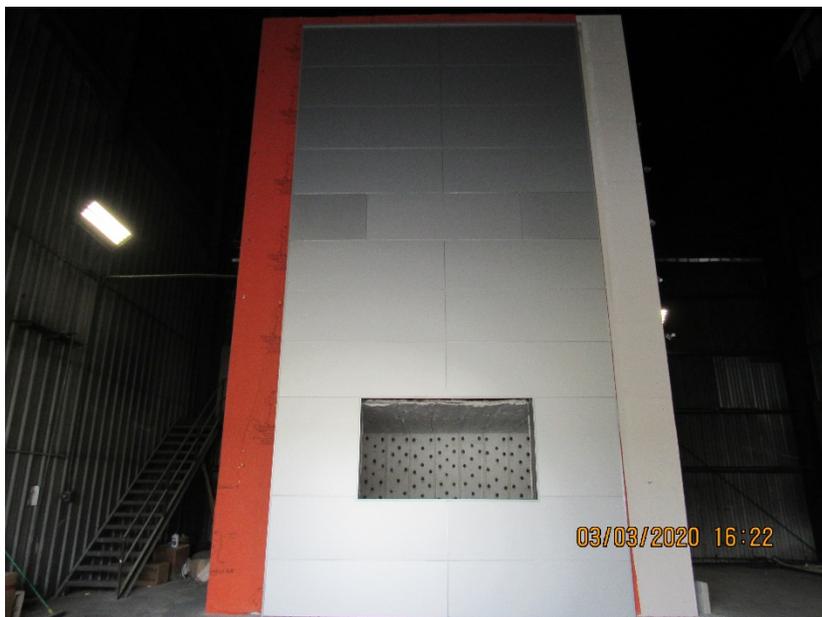
Photo No. 14
Completed Assembly

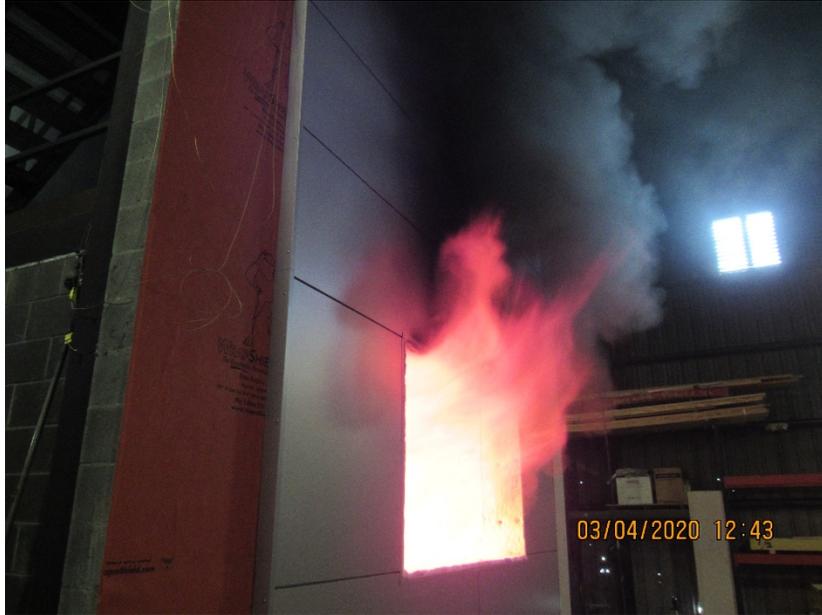
Photo No. 17
Panels starting to burn

FIRE-RESISTANCE TEST OBSERVATIONS (03-06-2020)	
Time (min:sec)	Observations
00:00	Test start at 10:38 am
3:20	Flames exiting window
7:30	Paint on panels flare up
11:00	Flaming above window
11:30	Panels melting above window
15:30	Flame tips at 1m

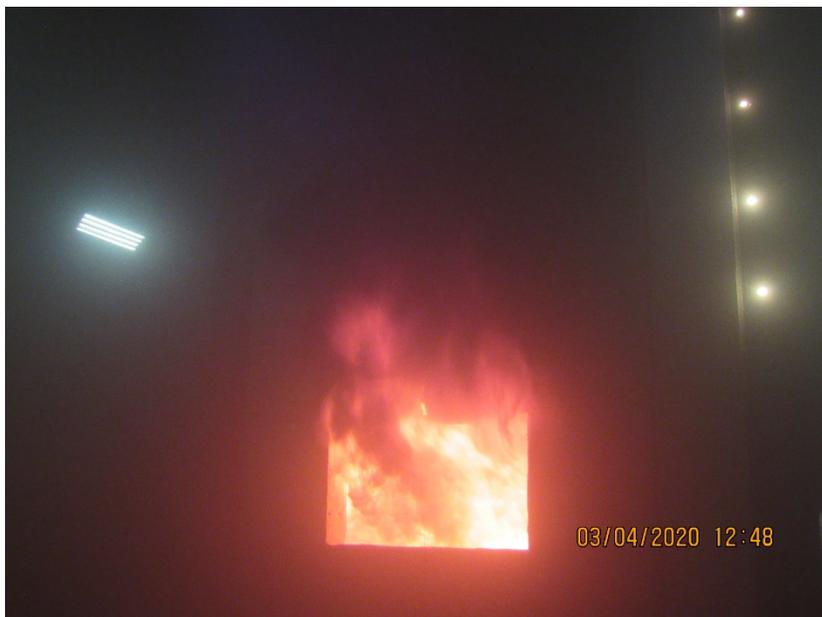
Photo No. 18
Flaming above window

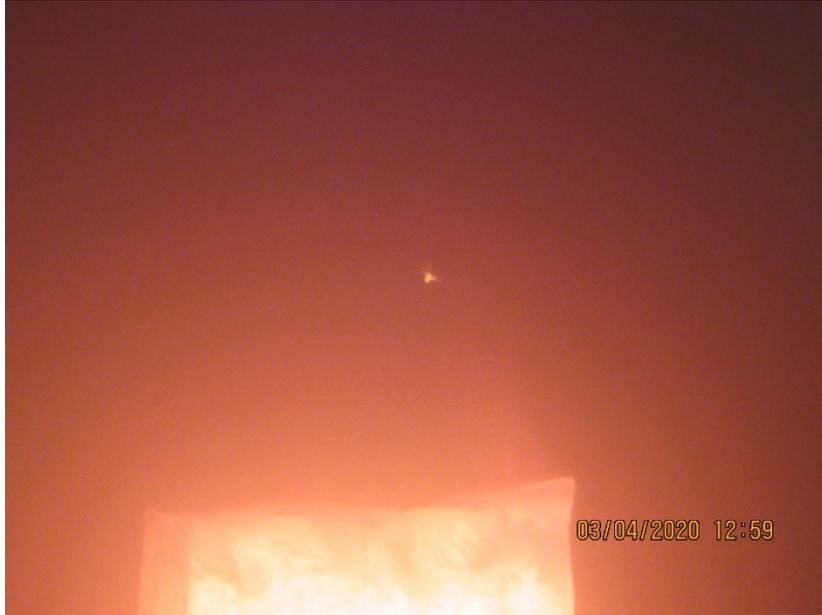
Photo No. 19
Flaming behind panels

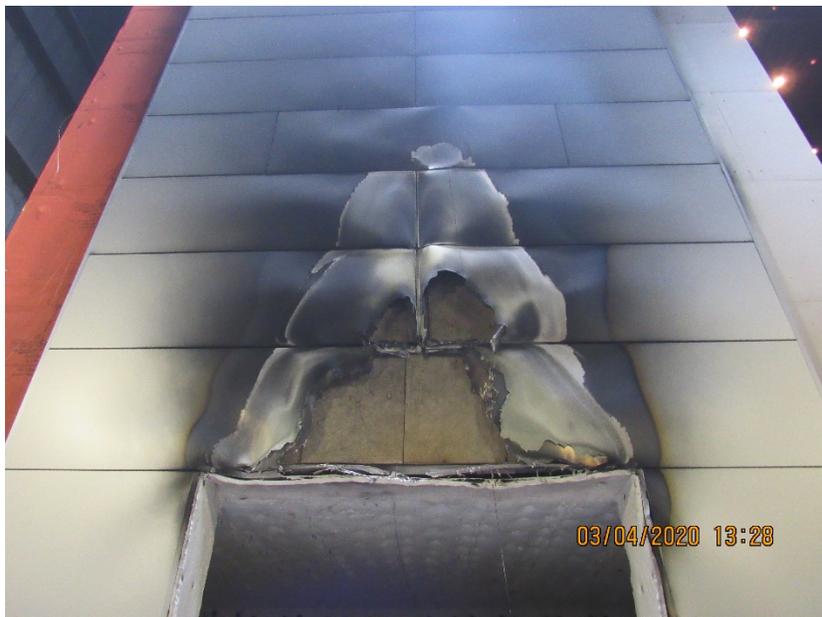
Photo No. 20
Post-test #1

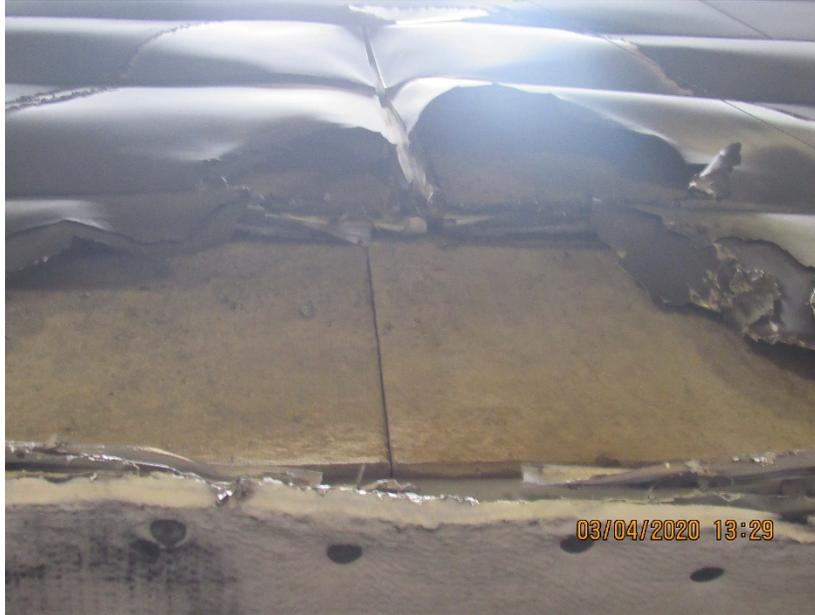
Photo No. 21
Post-test #1 insulation

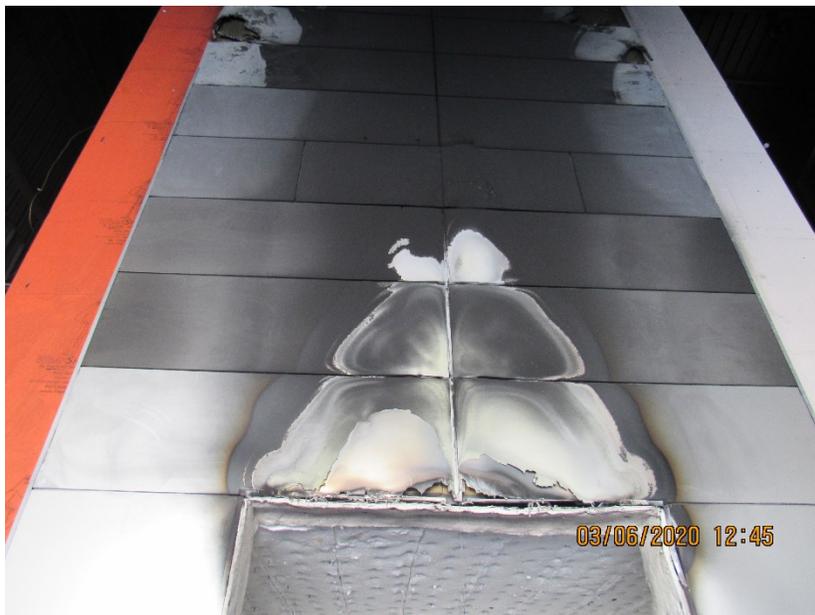
Photo No. 22
Post-test #2

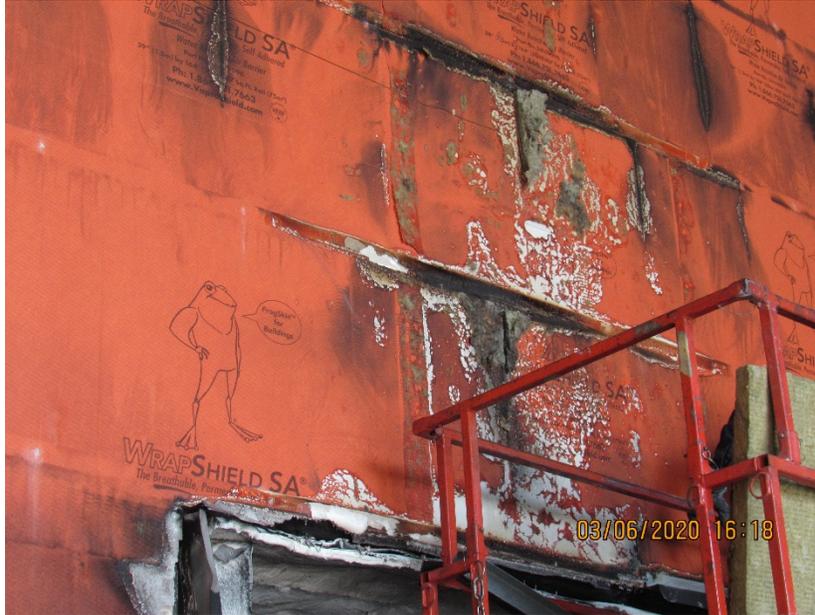
Photo No. 23
Post-test WRB #2

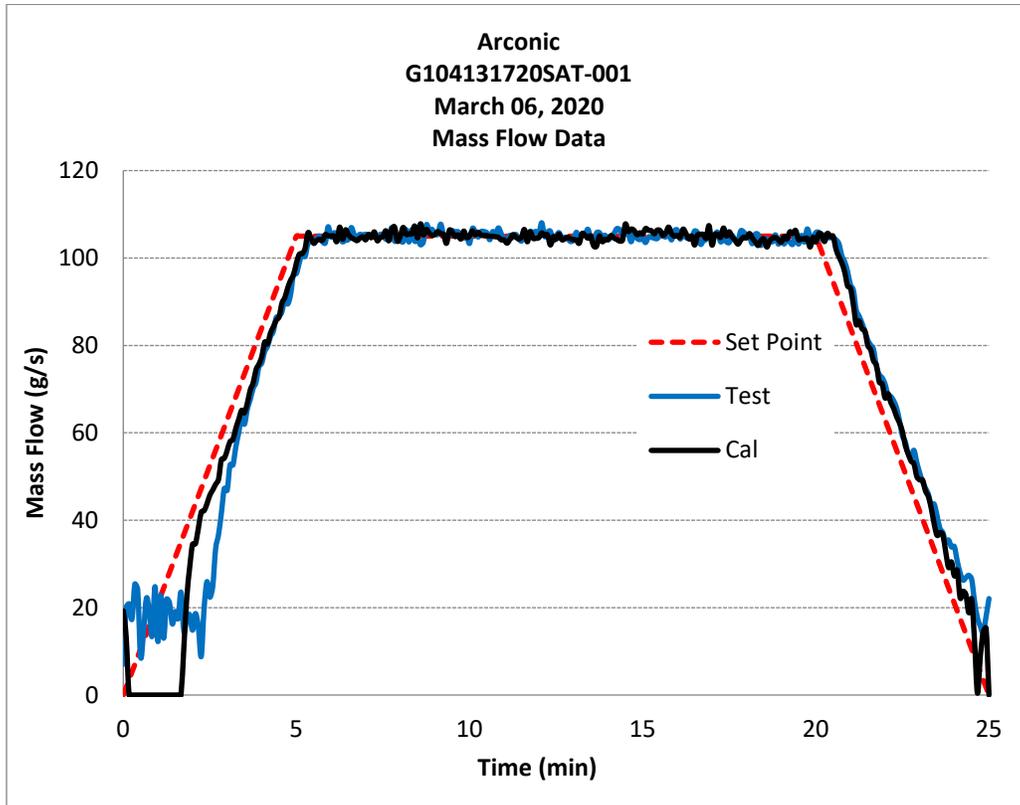
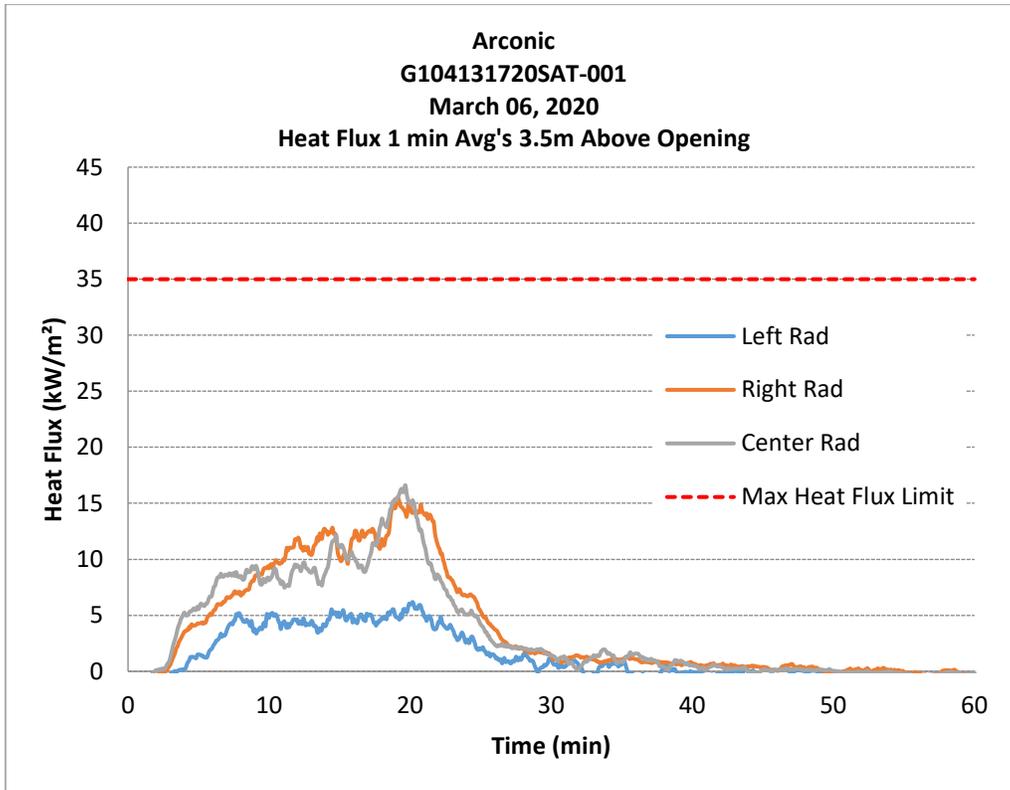
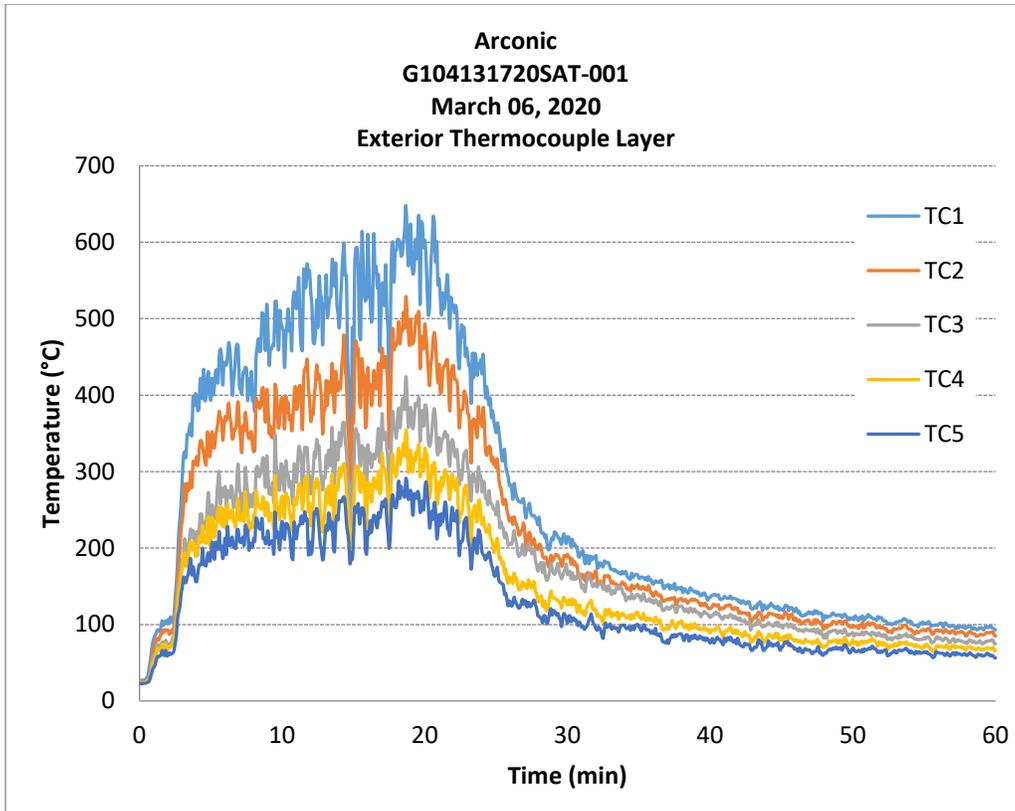
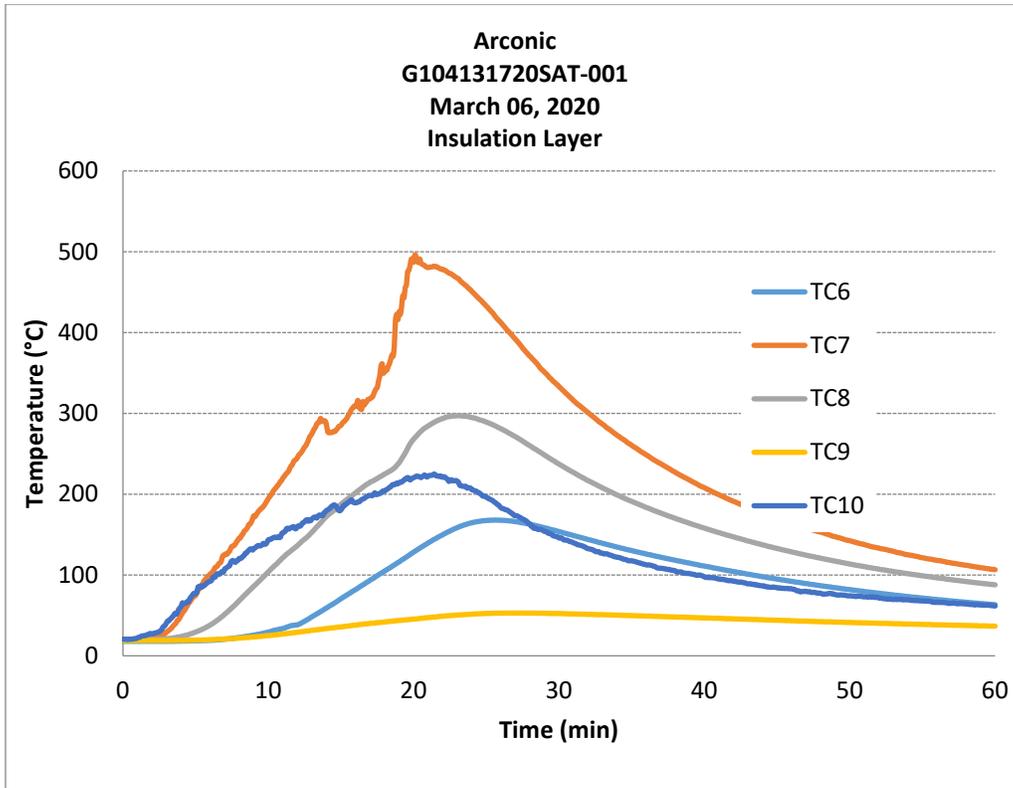
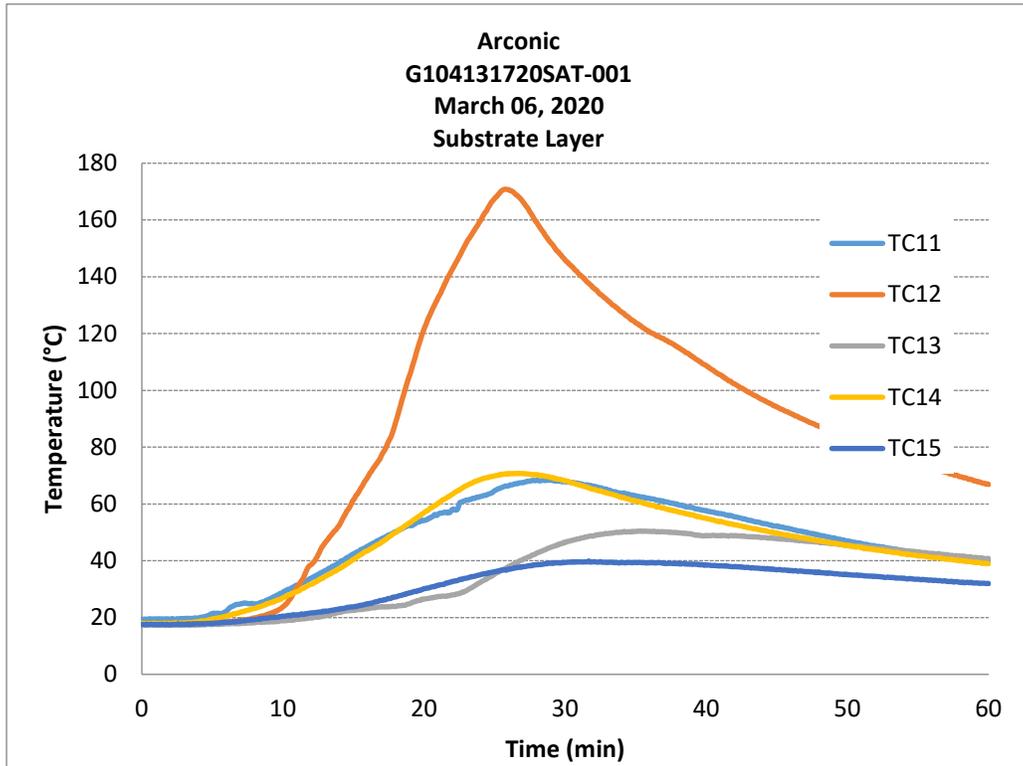
GRAPHS

The output of the transducers and thermocouples were monitored by a National Instruments CDAQ-9188 Data Acquisition Unit. The data acquisition system was programmed to scan and save data every 5 seconds. Following the test, the files were imported into MS Excel for tabular and graphical display. The graphical display data can be found in Section 14.

Data for the three radiometers installed at the 3.5 m height above the window is listed in the table below. The maximum flame spread observed above the window opening was 3 m. The maximum average heat flux determined as required by the standard was 16.6 kW/m². Plots of the data can be found in Section 14.

Location:	Max. Value (kW/m ²)	Time at Max. Value (min.)
Left Radiometer:	6.2	20.1
Center Radiometer:	16.6	19.6
Right Radiometer:	15.5	19.0

Maximum flame spread was 2 meters above the window opening at 17 minutes into test.

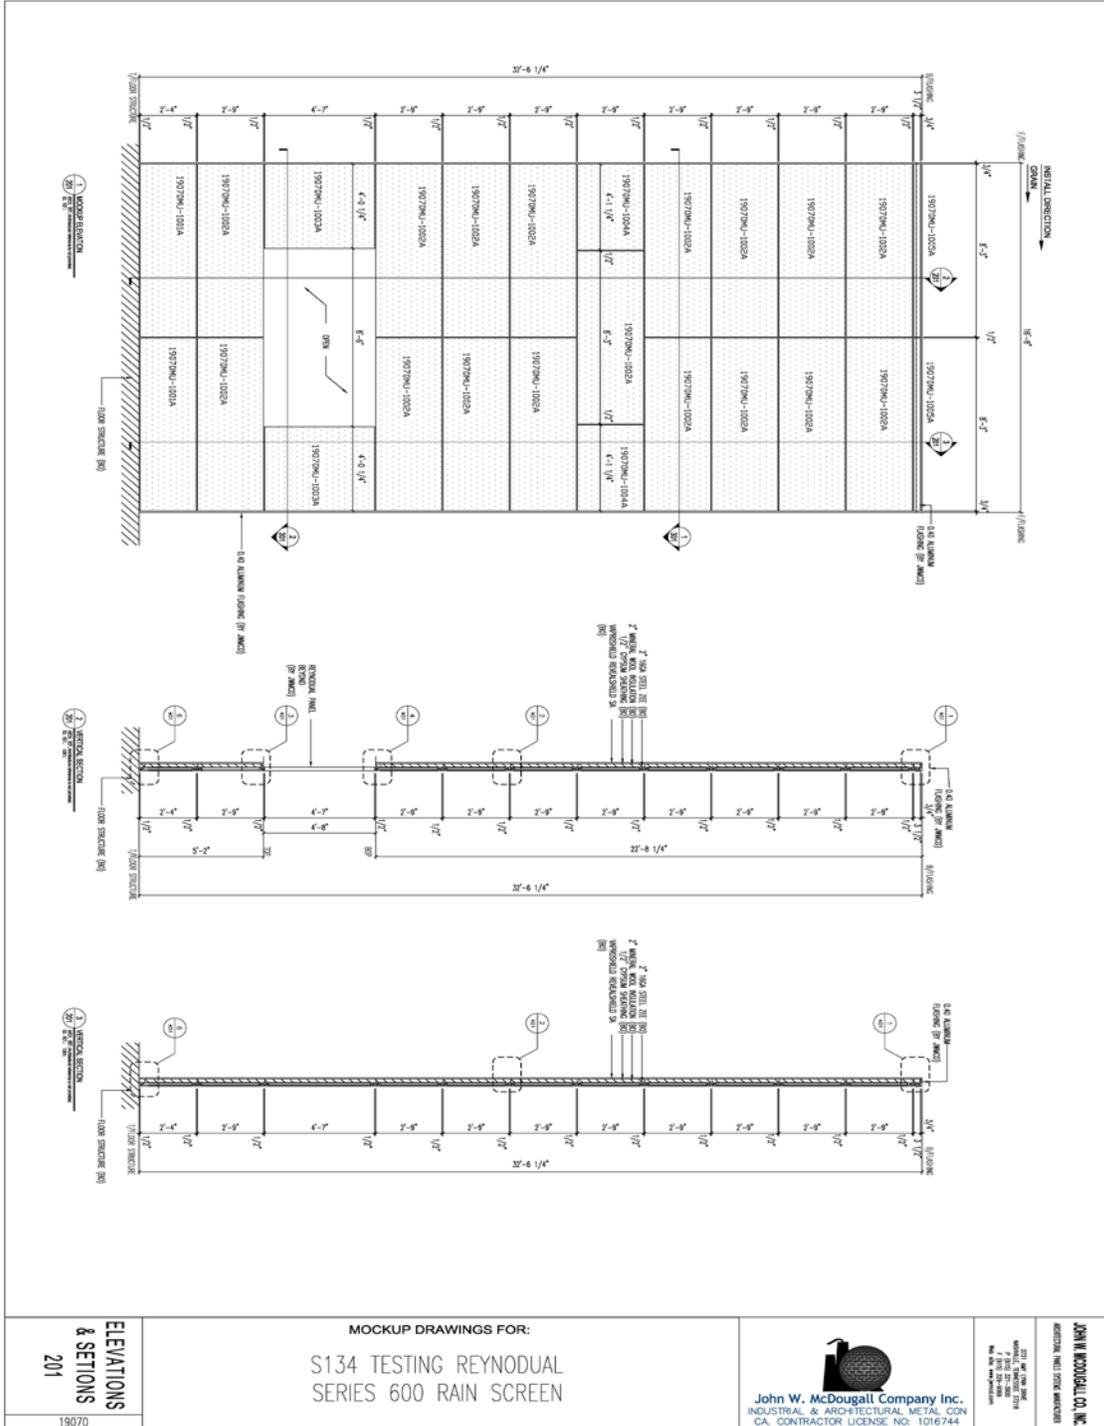
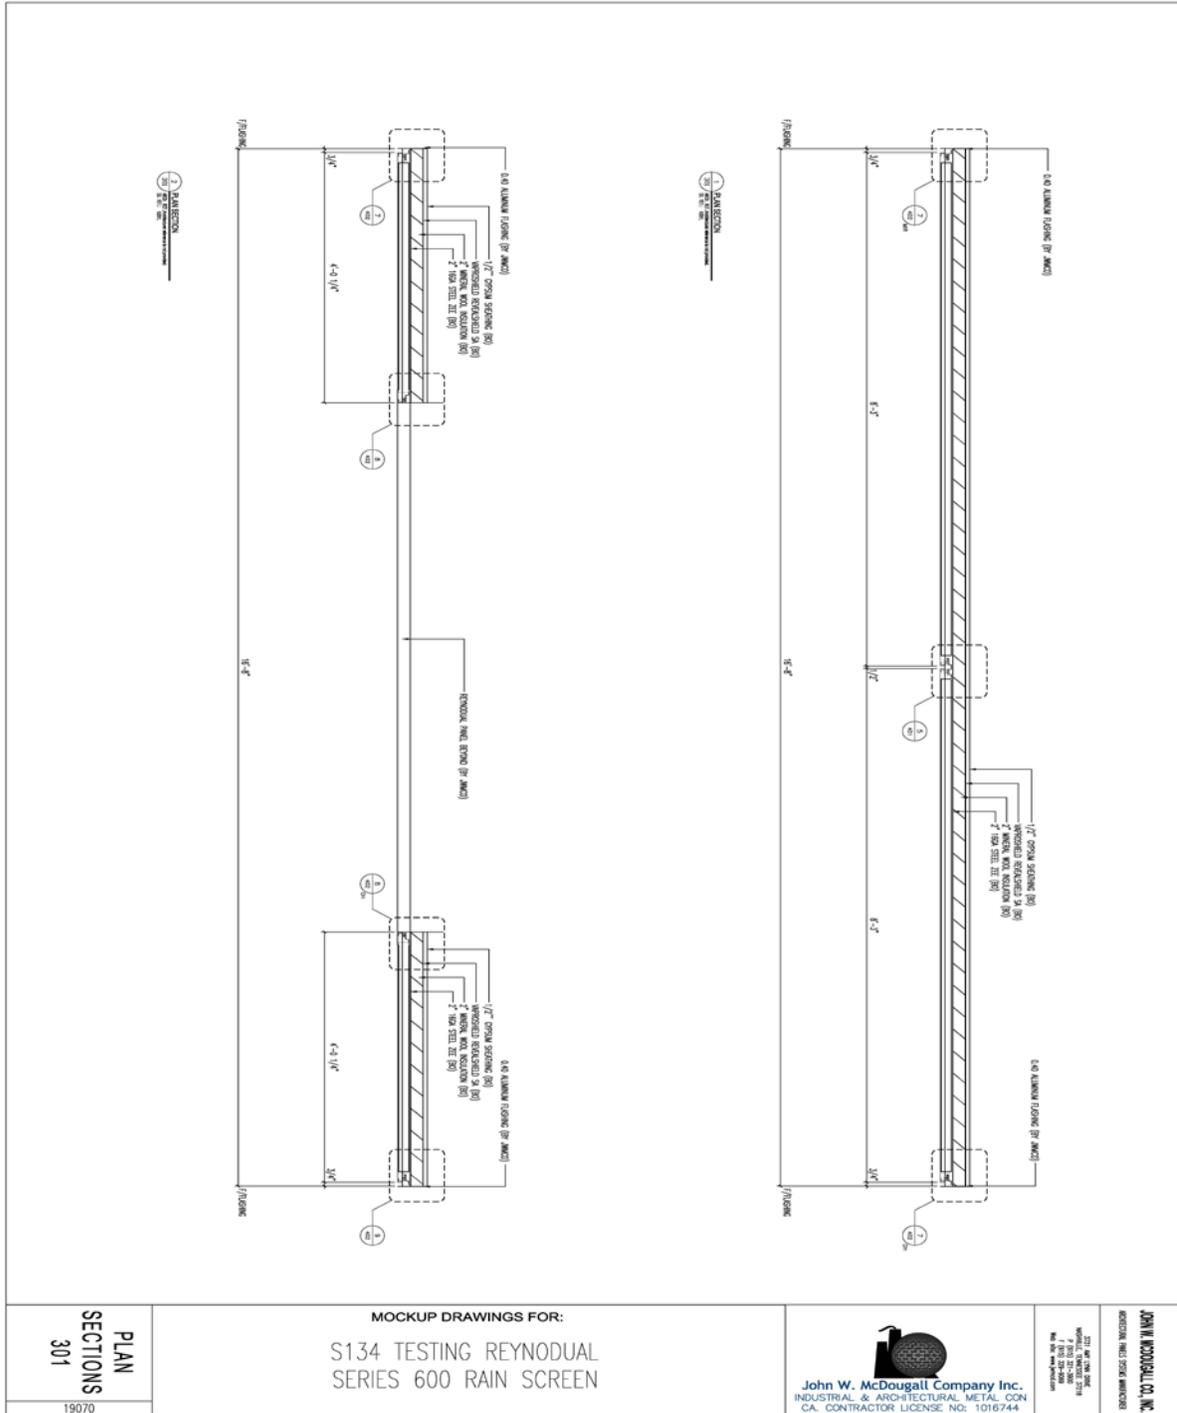
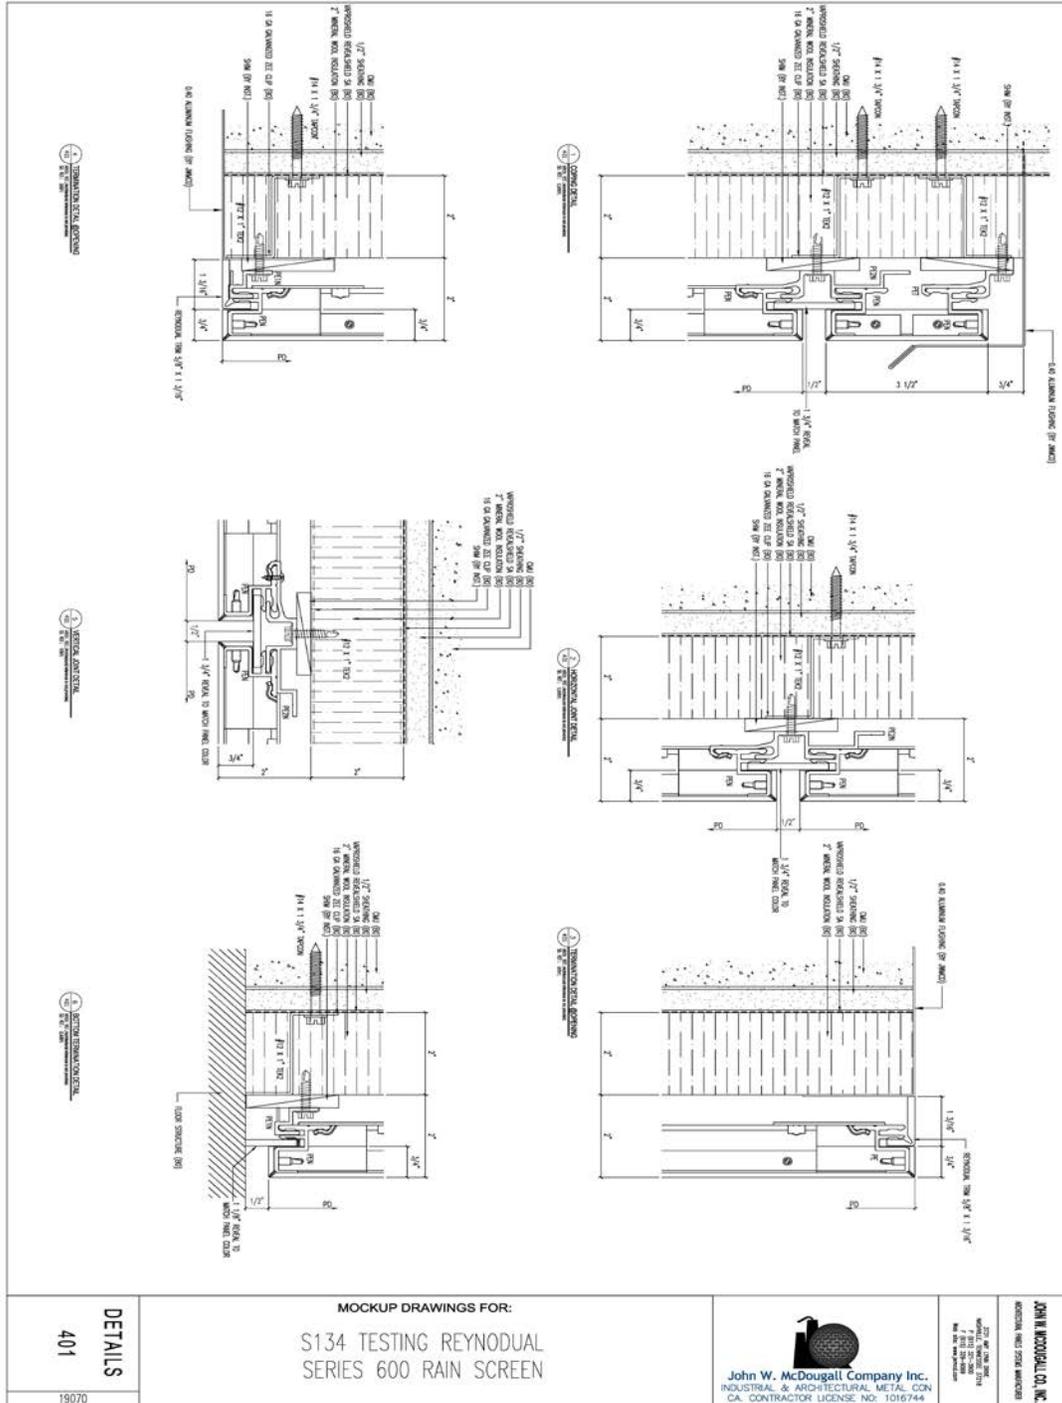
DRAWINGS

The "As-Built" drawings which follow have been reviewed by Intertek B&C and are representative of the project reported herein. Project construction was verified by Intertek B&C per the drawings included in this report. Any deviations are documented herein or on the drawings.

The concrete base wall was sheathed with one layer of 1/2 in. thick gypsum sheathing.

See Section 15 for detailed drawings of the test assembly.
