ARCONIC ARCHITECTURAL PRODUCTS TEST REPORT

CAN/ULC S134, STANDARD METHOD OF FIRE TESTS OF EXTERIOR WALL ASSEMBLIES

G105154183SAT-003 R1

Intertek Testing Services NA, Inc. dba Intertek Building & Construction (B&C) was contracted by Arconic Architectural Products, 50 Industrial Drive, Eastman, GA 31023, to perform testing in accordance with CAN/ULC-S134, *Standard Method of Fire Test of Exterior Wall Assemblies*, on their Reynobond® Aluminum Composite Panel assembly. Results obtained are tested values and were secured by using the designated test method(s). Testing was conducted at Intertek Testing Services test facility in Elmendorf, Texas.

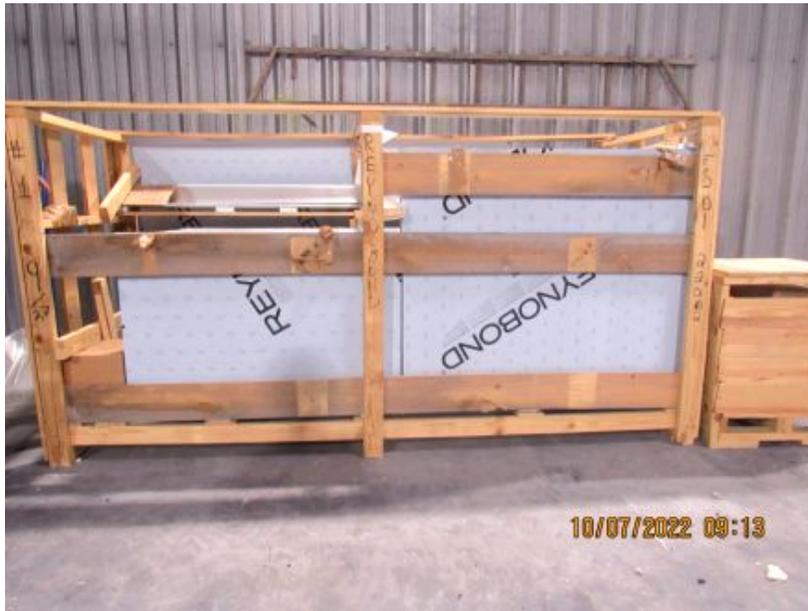
Photo No. 1
Materials received

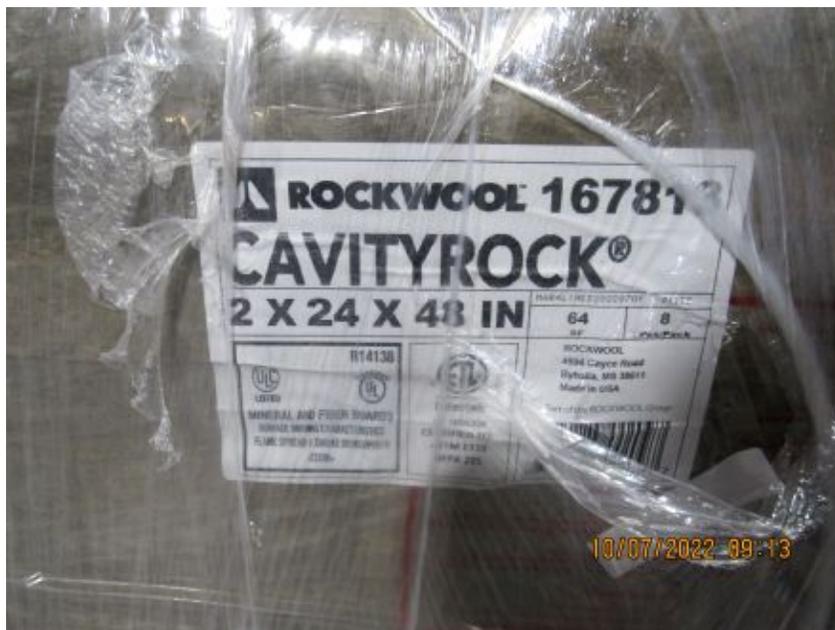
Photo No. 2
Mineral wool used

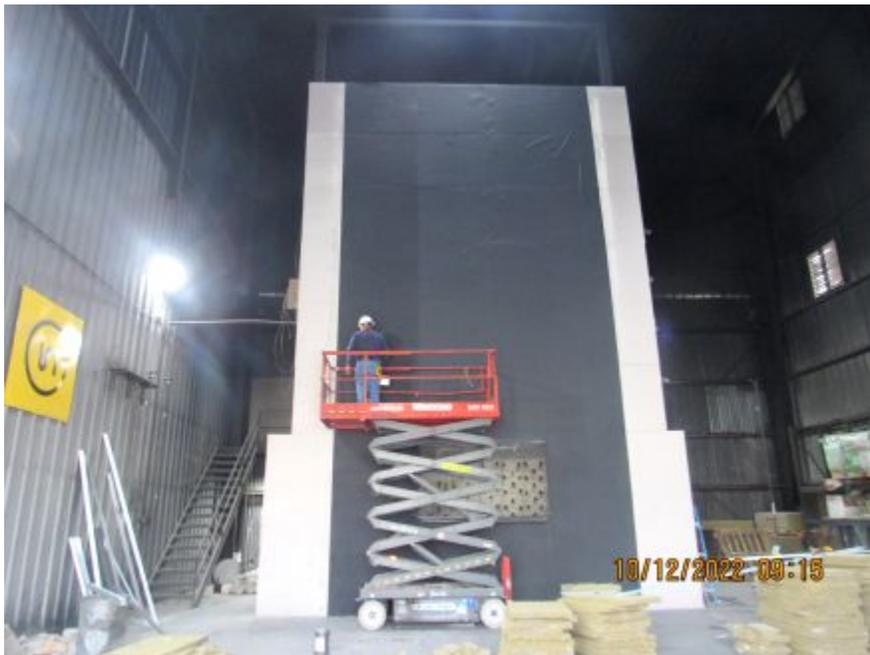
Photo No. 4
Weather barrier installed

VaproShield RevealFlashing SA® Self-Adhered vapor barrier was applied to the surface of the gypsum sheathing. 16GA, 2 in. galvanized zee girts were then installed to the weather barrier using 1/4" x 2-1/4" long concrete fasteners, spaced at nominal 12 in. oc. 2 in. mineral wool insulation was then installed between the zee clips, having a density of 4.3 pcf. The 4mm Reynobond series 600 ACM panels were installed to the zee girts using 3 in. wide aluminium extrusions clips, spaced at nominal 36 in. oc, attached using #14 x 2-1/2 in. self-drilling screws.

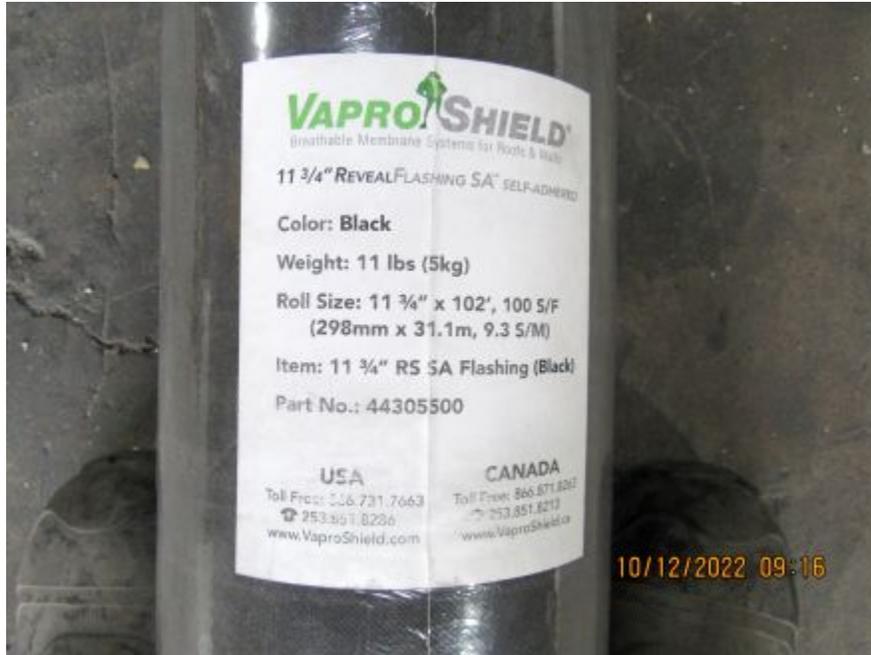
Photo No. 5
Weather barrier used

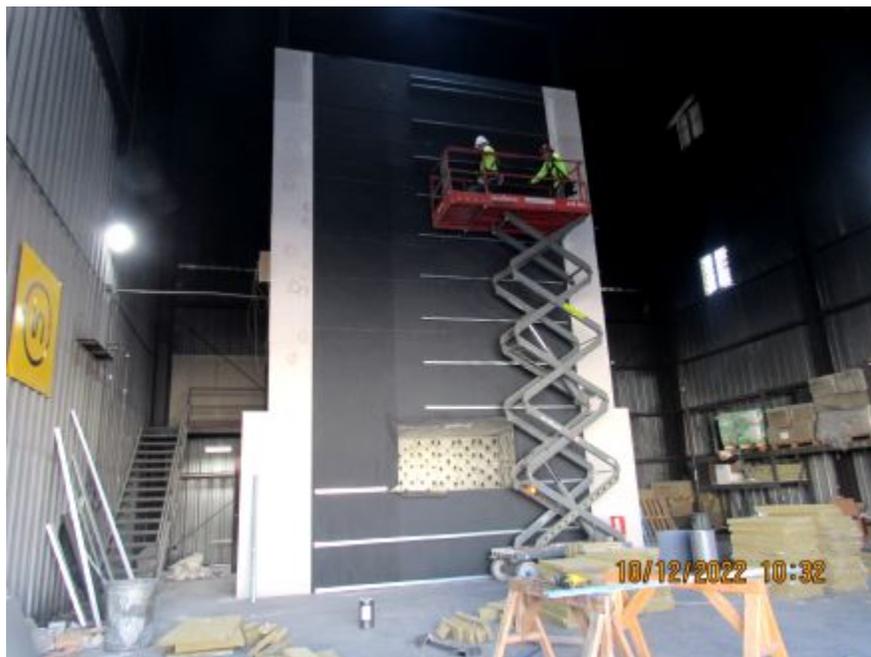
Photo No. 6
Installing Zee girts

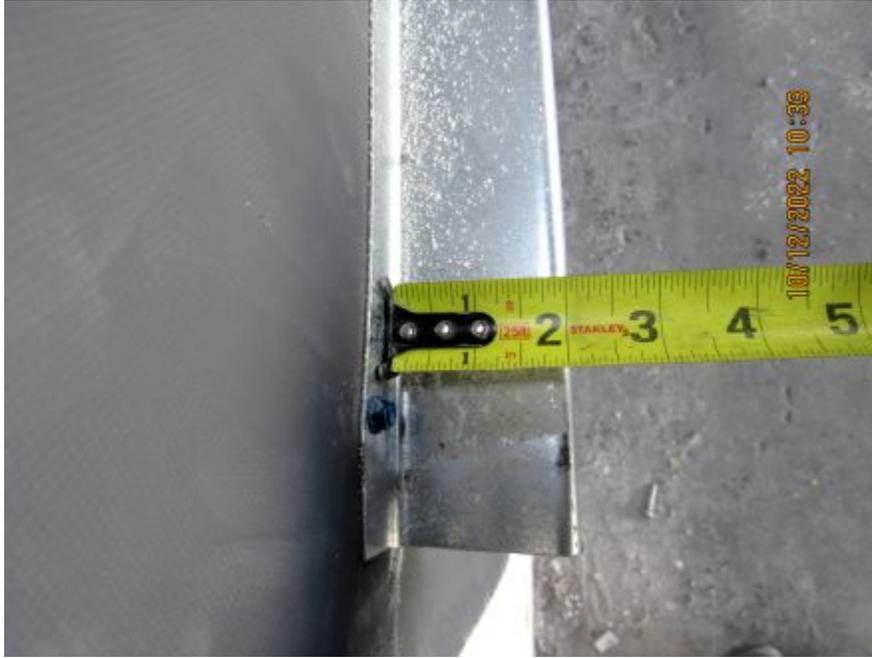
Photo No. 7
Zee girt depth

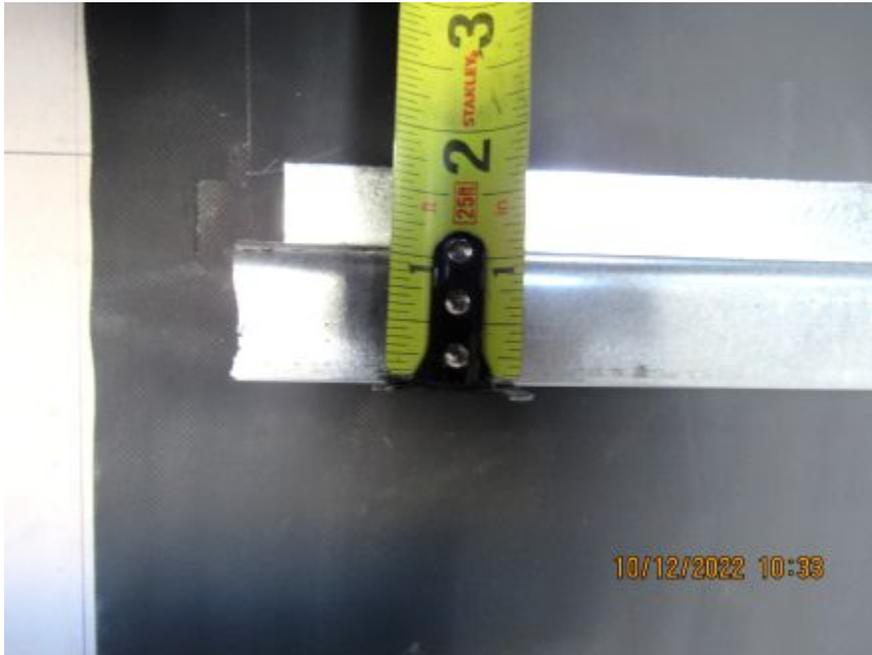
Photo No. 8
Zee girt lip height

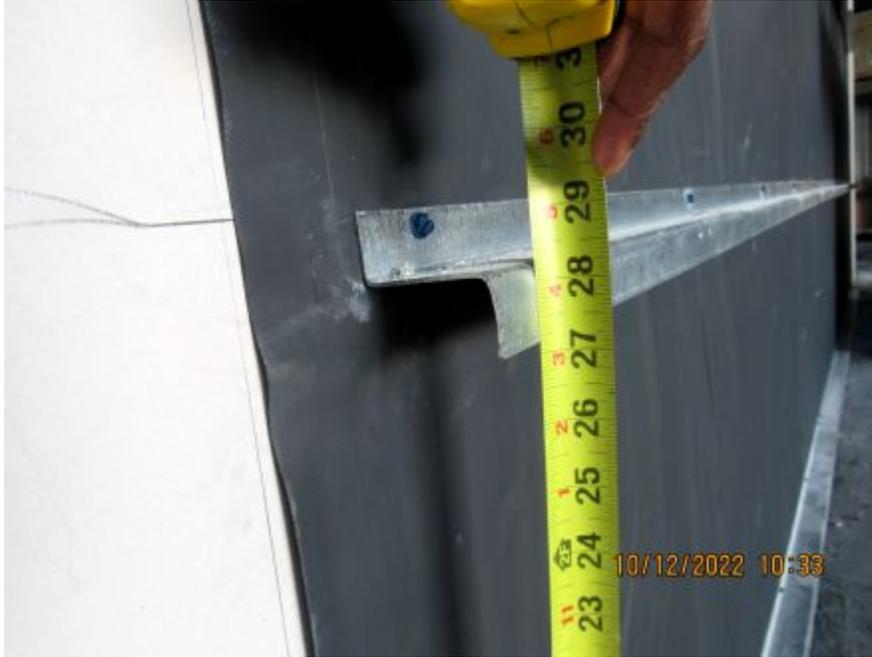
Photo No. 9
Zee girt spacing

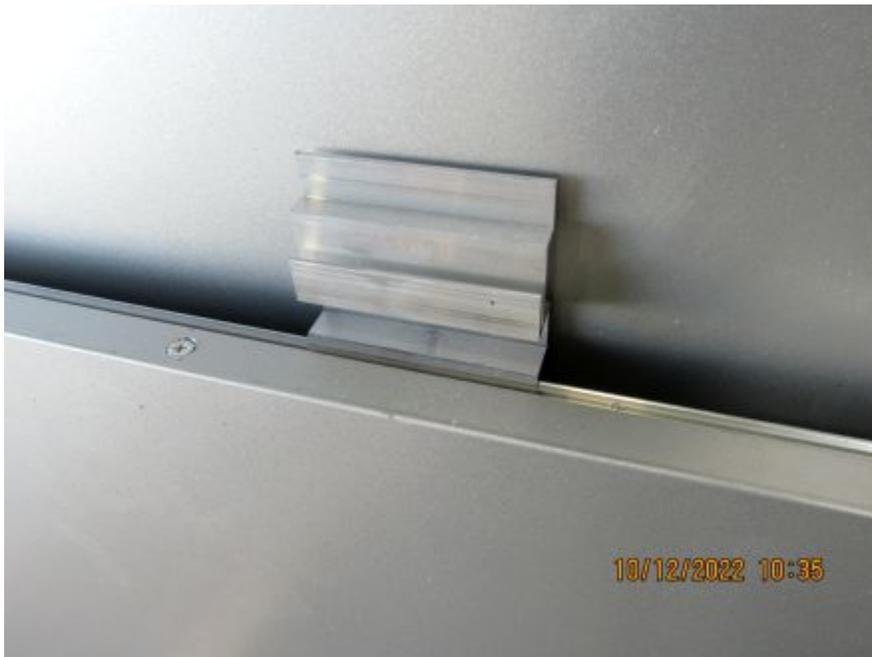
Photo No. 10
Panel clips installed onto panels

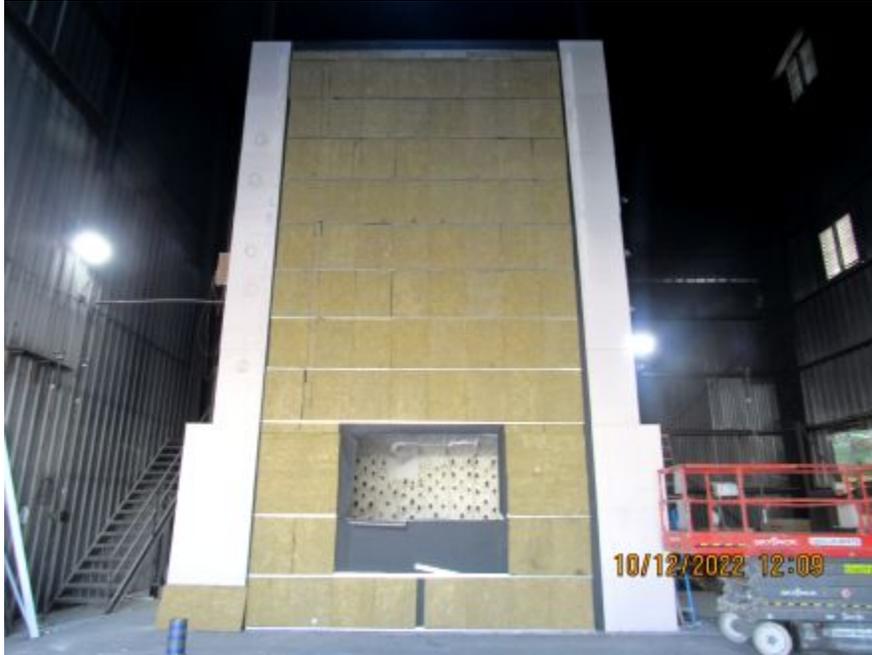
Photo No. 11
Mineral wool installed

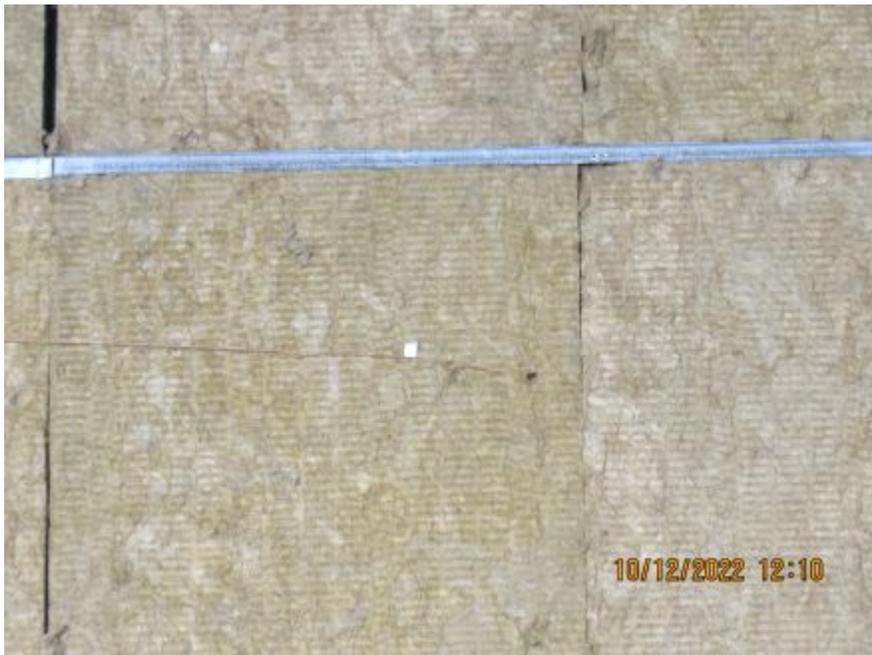
Photo No. 12
Thermocouple installed on mineral wool

- TCs 1-5: (Layer 1) Flush with exterior panels at 1.5 m, 2.5 m, 3.5 m, 4.5 m, and 5.5 m, respectively.
- TCs 6-10: (Layer 1) Flush with mineral wool at 1.5 m, 2.5 m, 3.5 m, 4.5 m, and 5.5 m, respectively.

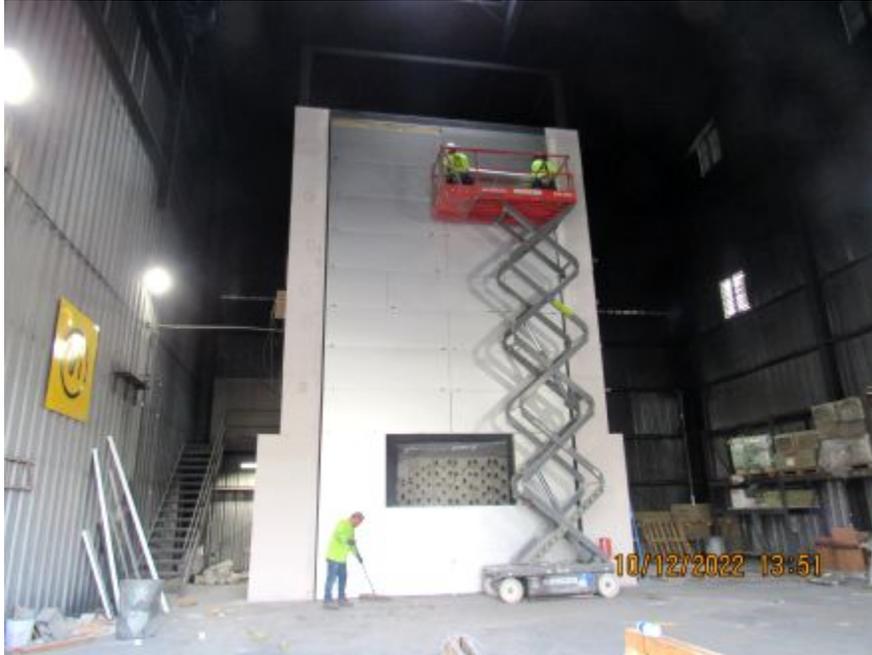
Photo No. 13
Panel installation

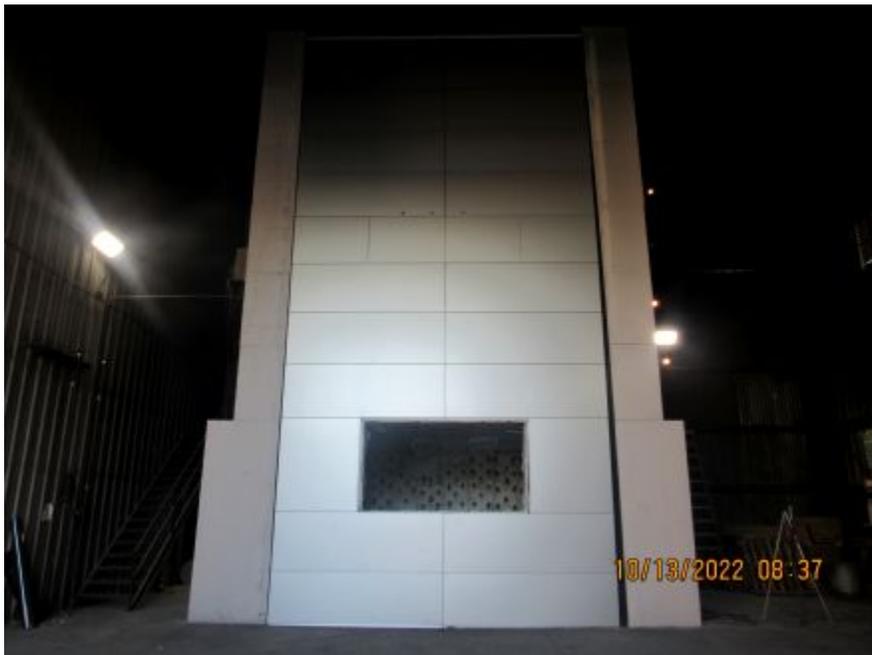
Photo No. 14
Assembly completed

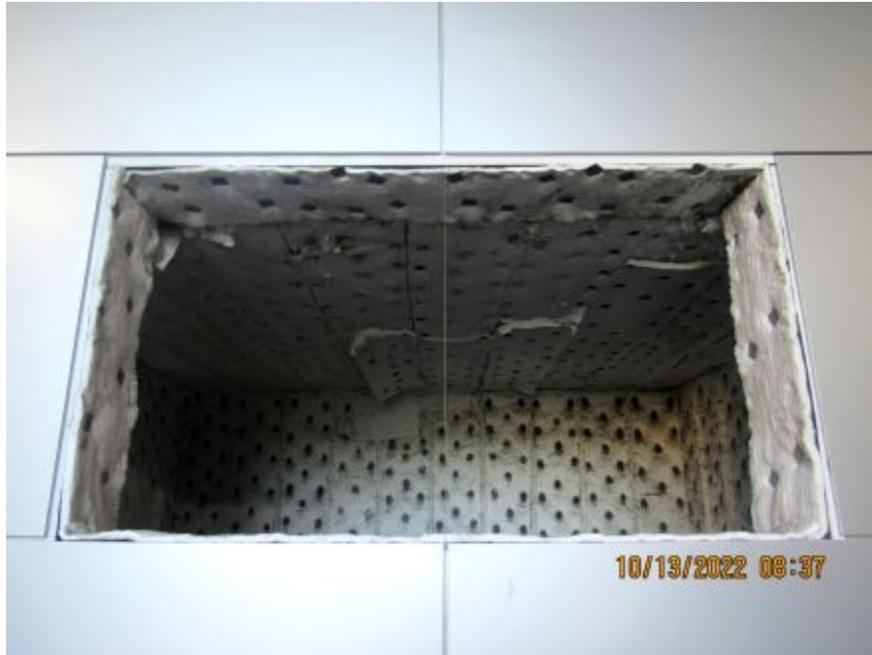
Photo No. 15
Window opening pre-test

The window opening jambs, sill and header were lined with .040 in. thick aluminum flashing, width of 4 in. This flashing was also used to seal the sides and top of the wall assembly. The header was also lined with 26GA steel flashing, width of 14 in. with 1 in. thick 6 pcf ceramic fiber blanket.

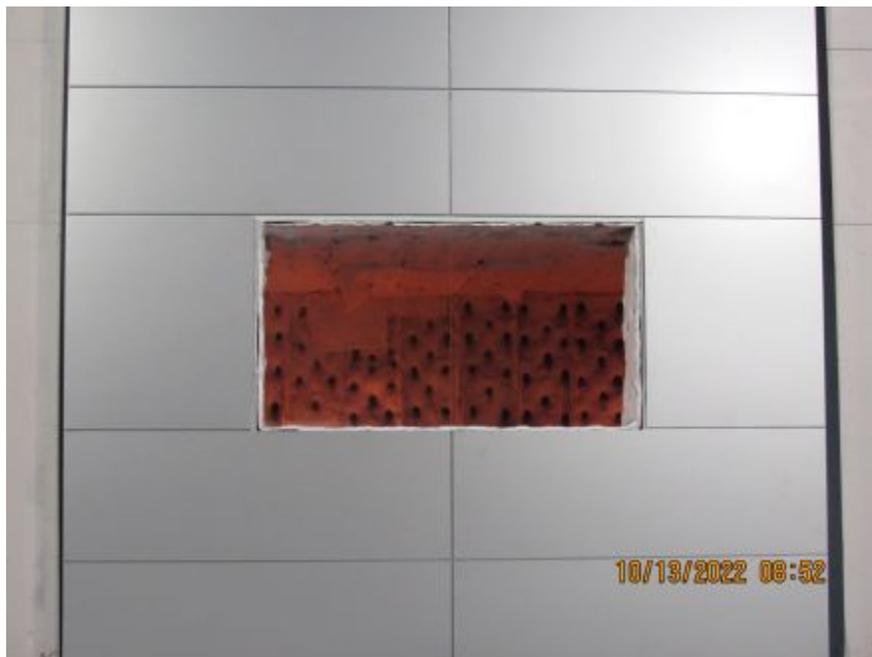
Photo No. 16
Pilot burner ignition, start of test

In accordance with CAN/ULC-S134, once ambient conditions are met, the pilot burners are lit. The test then starts with the ignition of the burners. The burners proceed, controlled as specified in the test method, with a 5 min growth period, followed by a 15 min steady state period, followed by a 5 min ramp down period to zero.

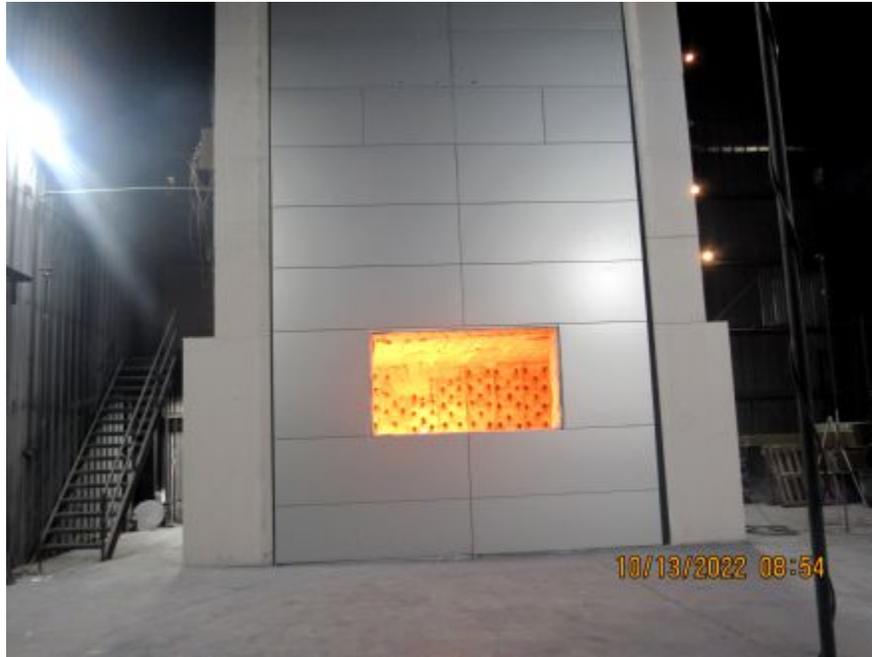
Photo No. 17
Gas increasing

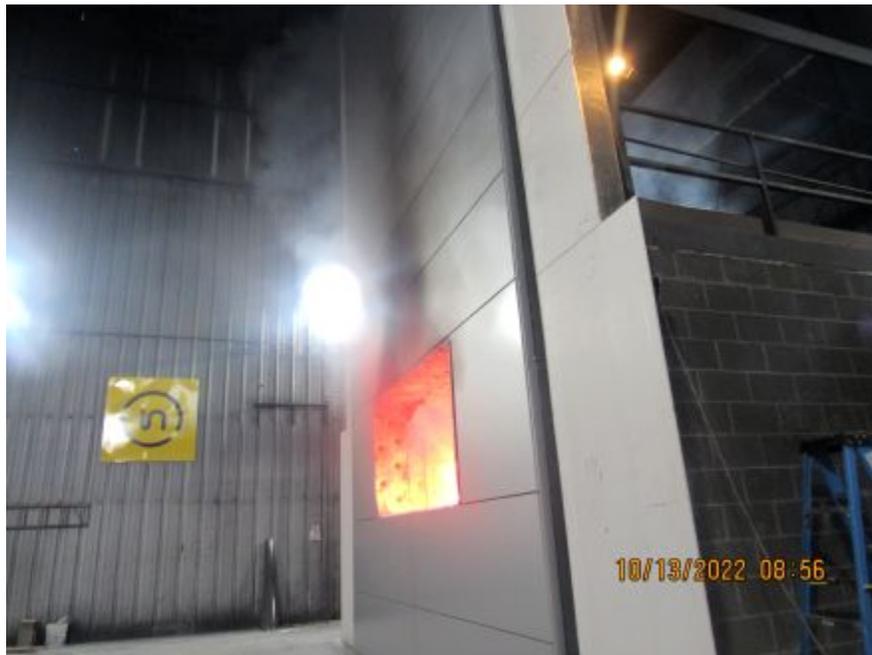
Photo No. 18
Flame tips exiting window opening

FIRE-RESISTANCE TEST OBSERVATIONS	
Time (min:sec)	Observations
00:00	Test started at 8:55 am
03:30	Flame tips exiting window opening
04:47	Panels starting to warp
06:22	Flaming at header
07:00	Panel faces melting
08:30	Panels opened up
08:50	Pieces of flaming panels dropping
14:50	Flaming behind panels up to 3.5 meters above window opening
16:00	Flame height seen around 4 meters
23:47	Flaming seen around 3 meters
25:00	Gas off, flaming at third horizontal joint above window
51:00	All flaming out, observation period over

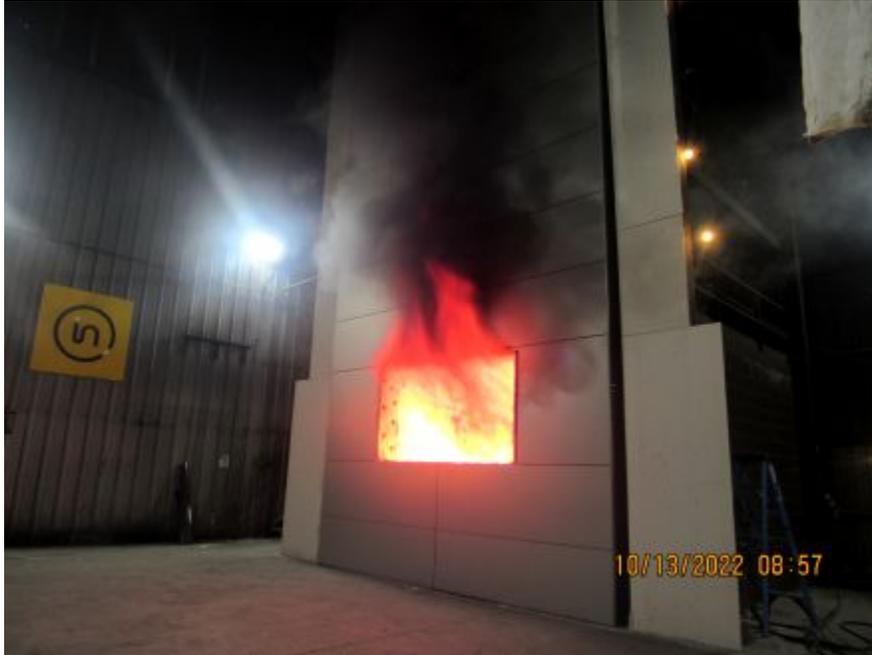
Photo No. 19
Flame tips at 1 meter

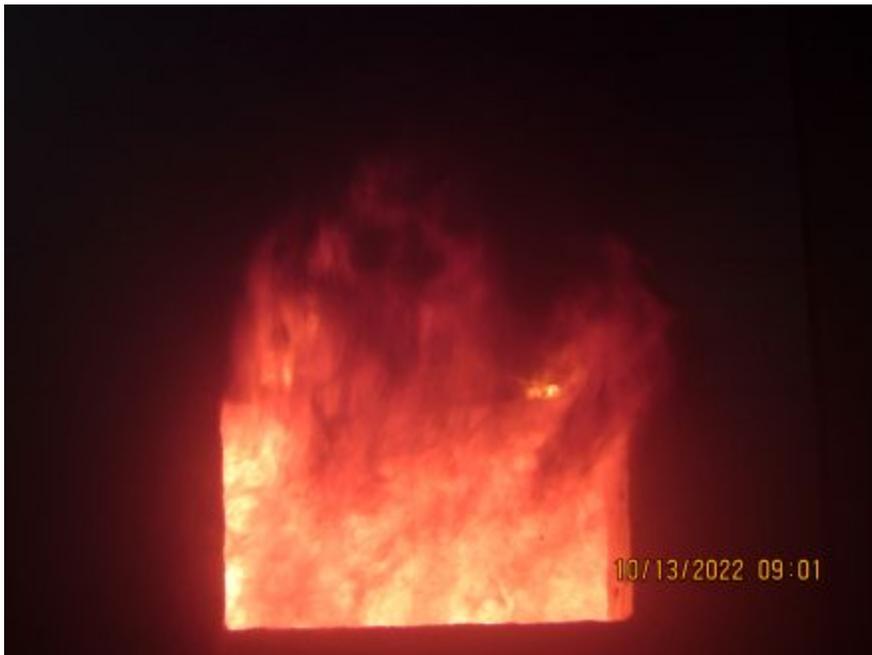
Photo No. 20
Flaming at window header

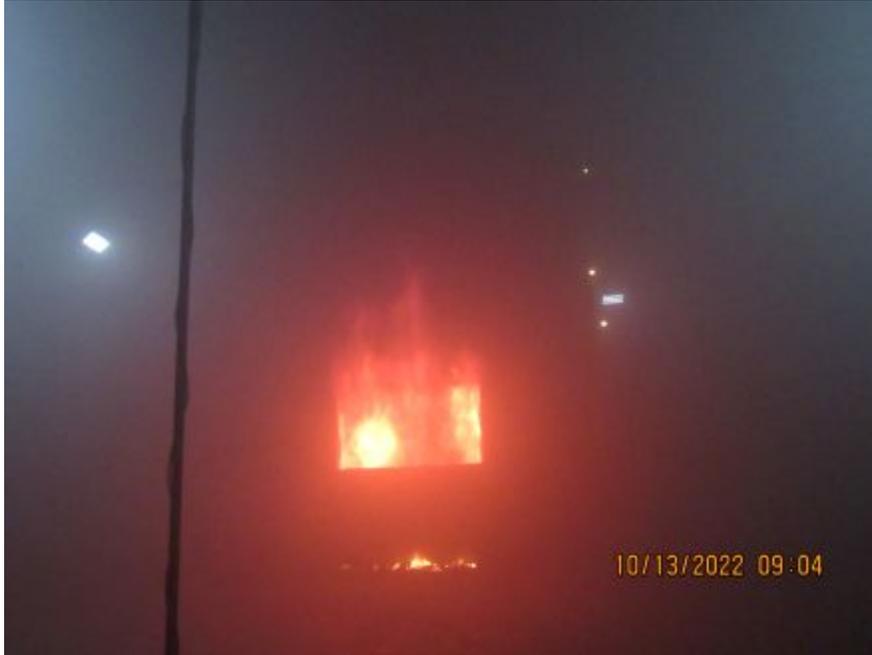
Photo No. 21
Flame increased to 2.5 meters

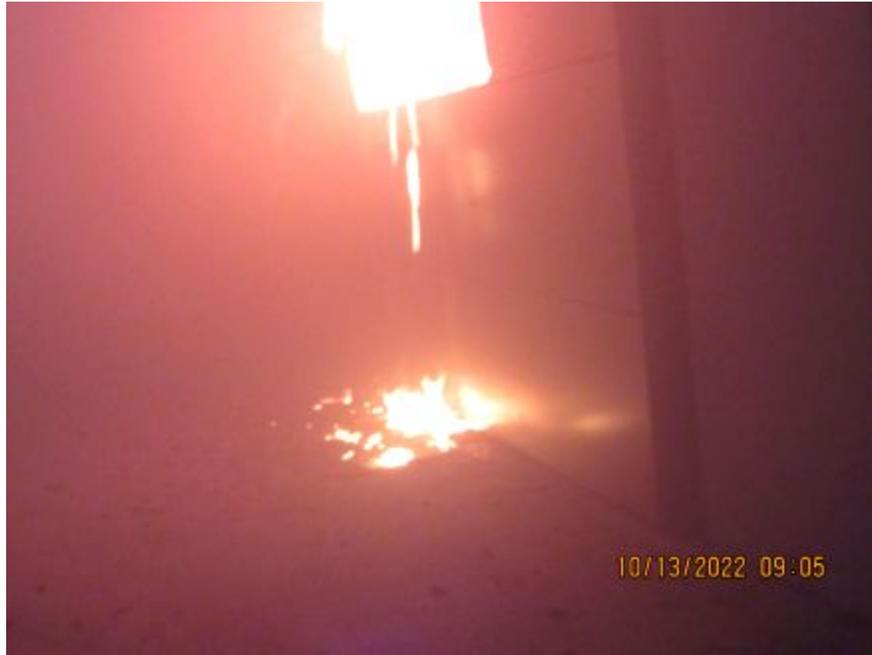
Photo No. 23
Pieces of flaming panels dropping

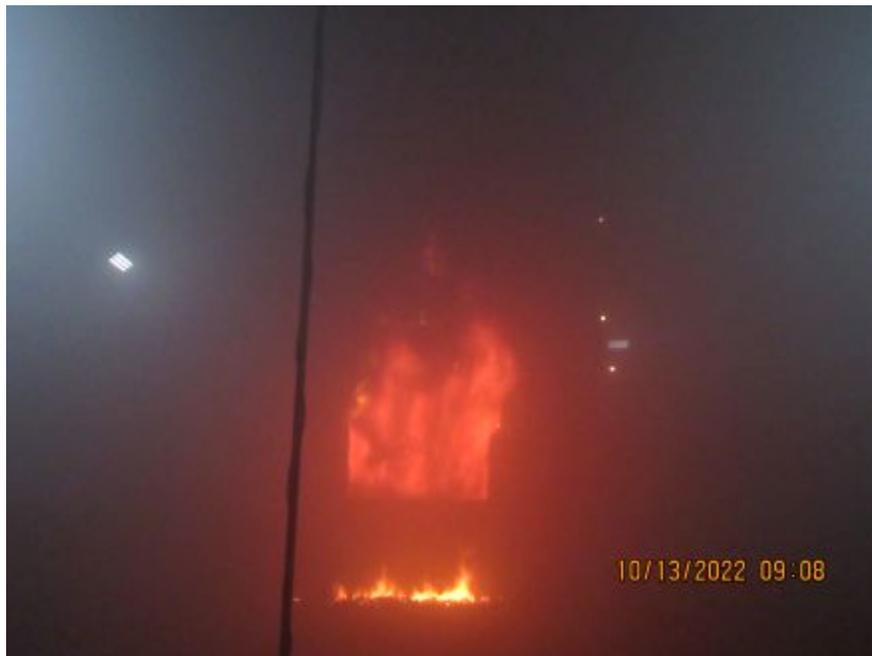
Photo No. 24
Flame height at 4 meters

Data for the three radiometers installed at the 3.5 m height above the window is listed in the table below. The maximum flame spread observed above the window opening was **4 m**. The maximum average heat flux determined as required by the standard was **23.8 kW/m²**.

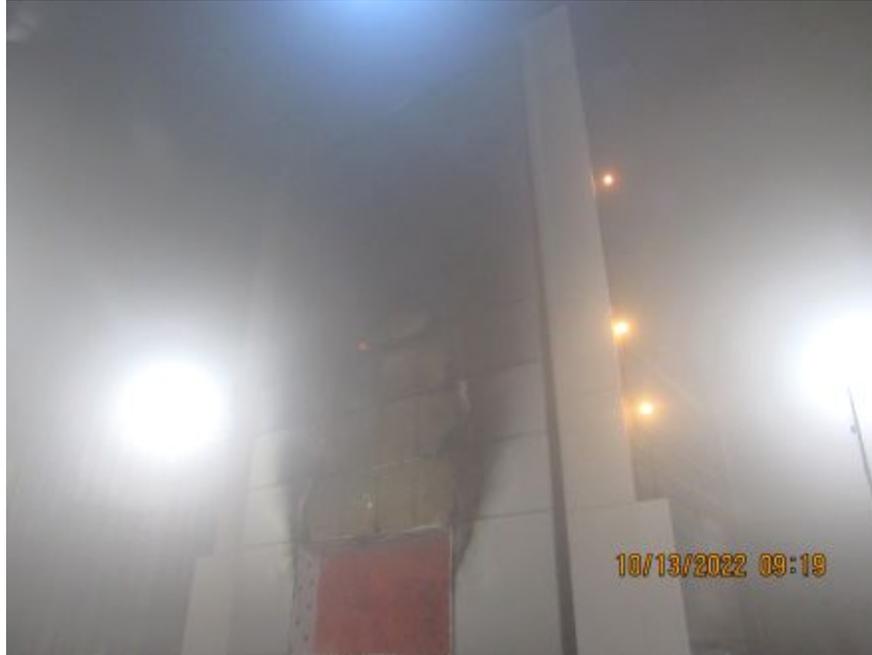
Photo No. 25
End of test, residual flaming at 2.5 meters

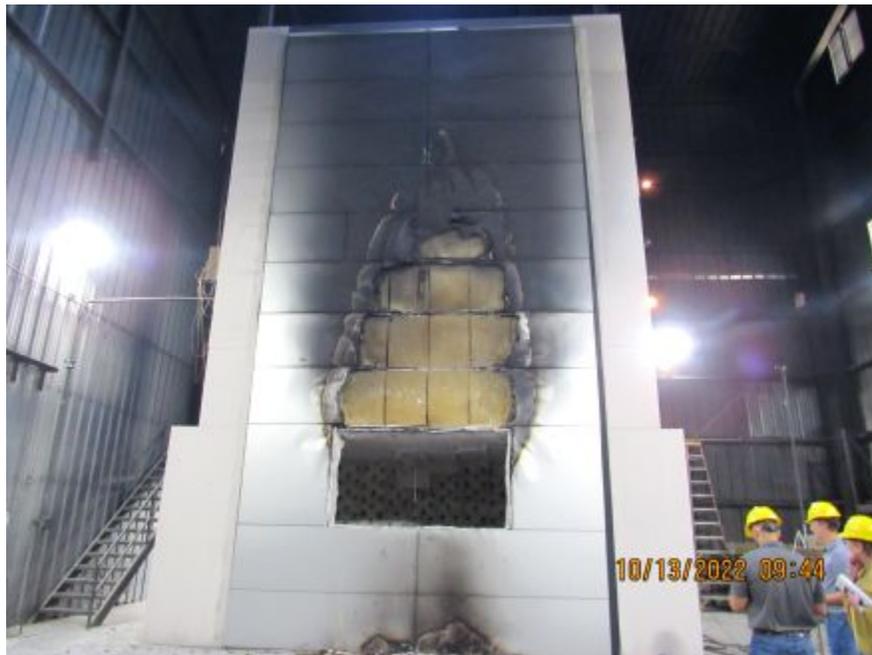
Photo No. 26
Post-test

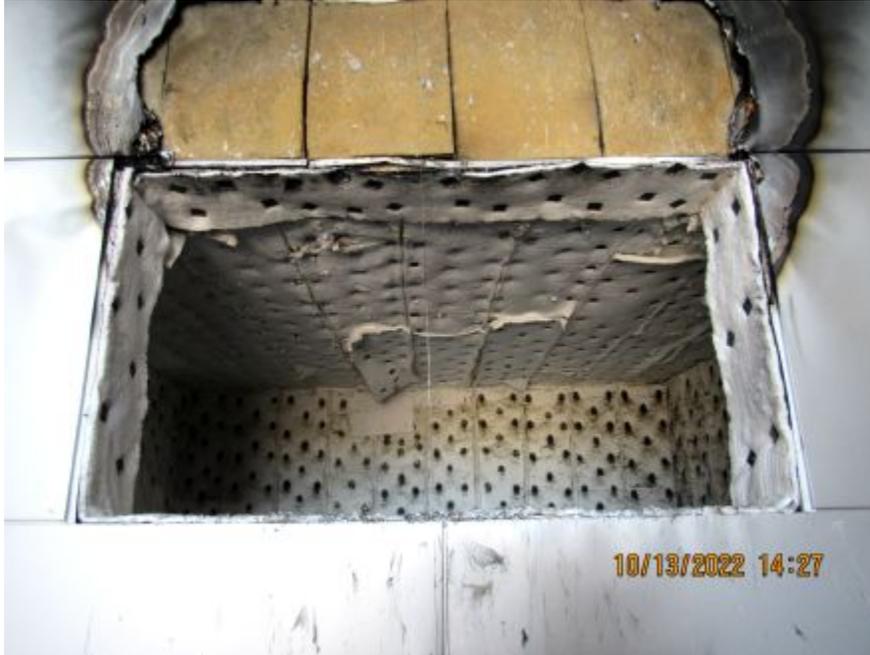
Photo No. 27
Window opening post-test

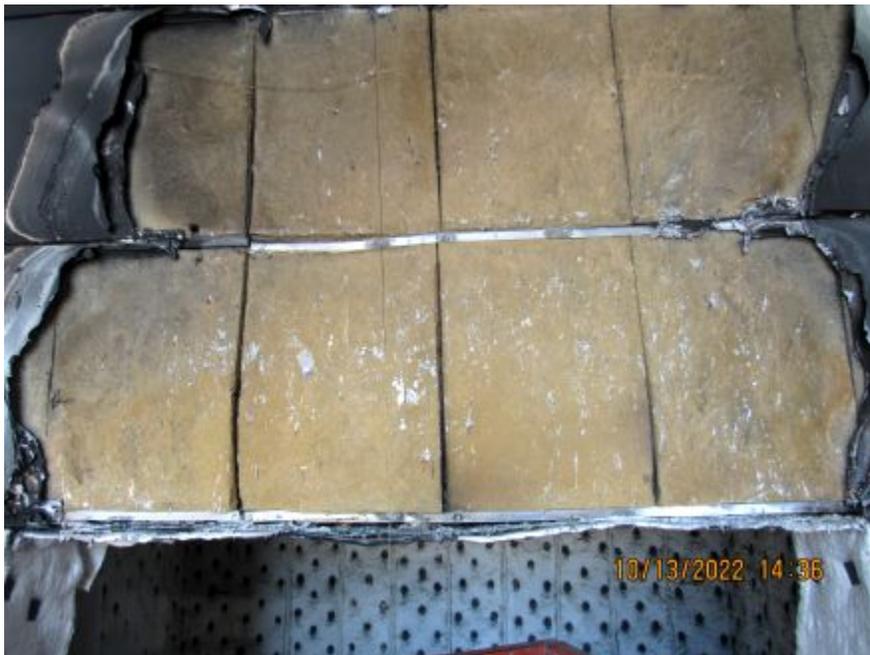
Photo No. 28
Mineral wool above window opening post-test

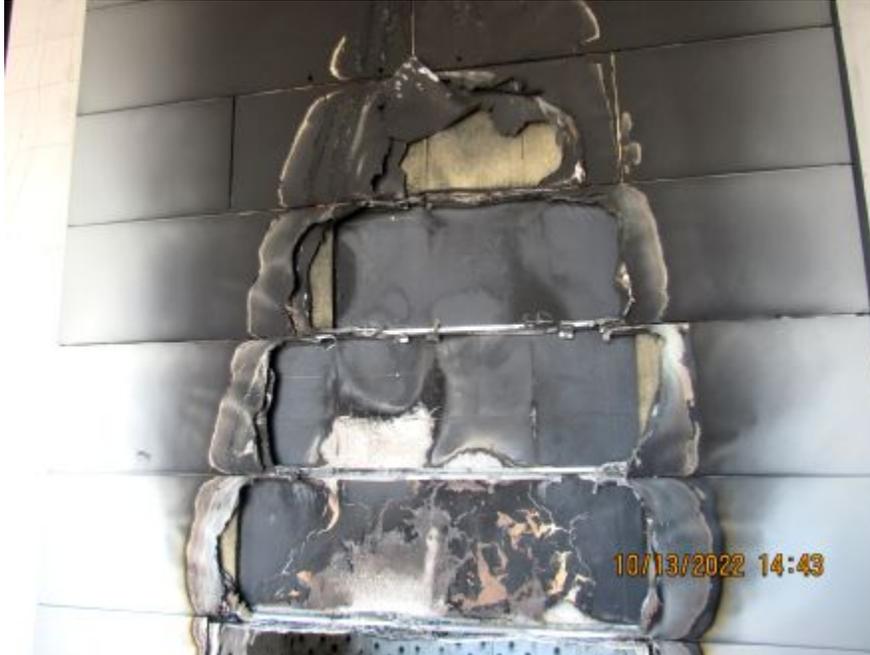
Photo No. 29
Weather barrier damage post-test

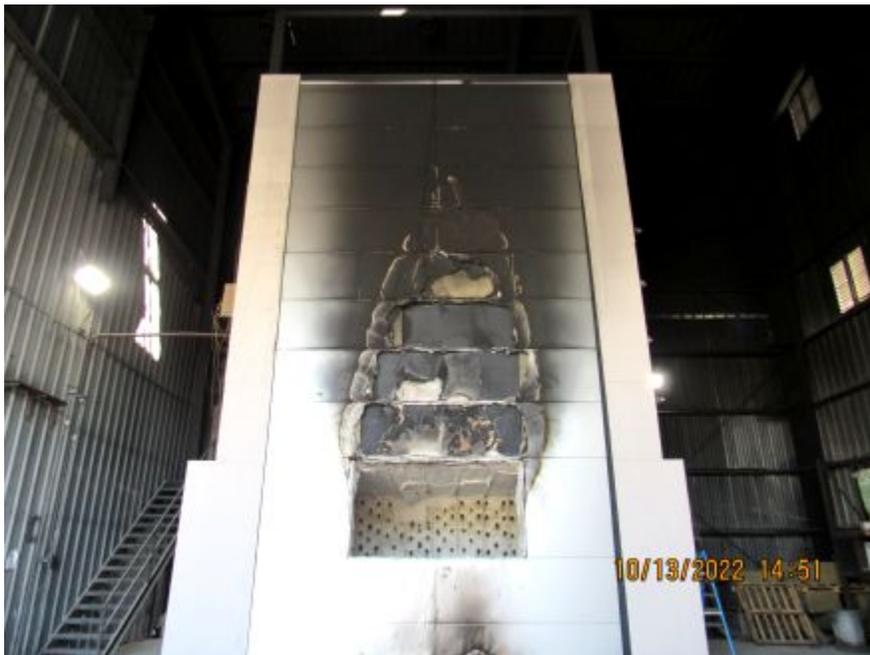
Photo No. 30
Wall assembly post-test
