ARCONIC ARCHITECTURAL PRODUCTS TEST REPORT

CAN/ULC S134, STANDARD METHOD OF FIRE TESTS OF EXTERIOR WALL ASSEMBLIES

G105154183SAT-003 R1

Intertek Testing Services NA, Inc. dba Intertek Building & Construction (B&C) was contracted by Arconic Architectural Products, 50 Industrial Drive, Eastman, GA 31023, to perform testing in accordance with CAN/ULC-S134, *Standard Method of Fire Test of Exterior Wall Assemblies*, on their Reynobond® Aluminum Composite Panel assembly. Results obtained are tested values and were secured by using the designated test method(s). Testing was conducted at Intertek Testing Services test facility in Elmendorf, Texas.

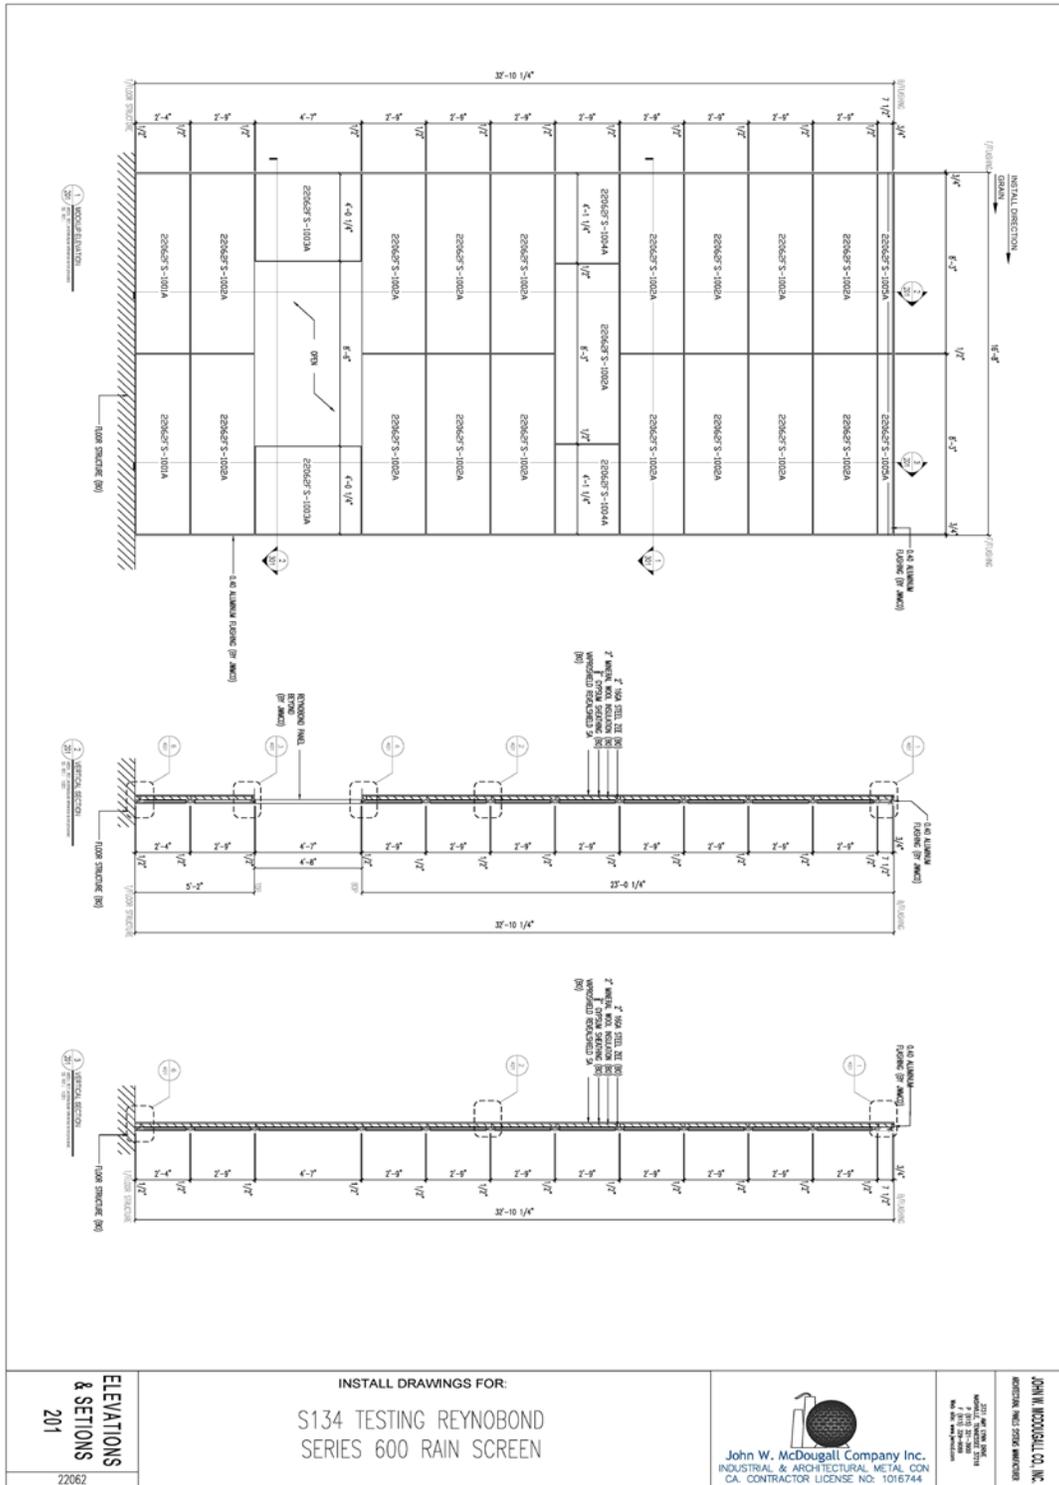
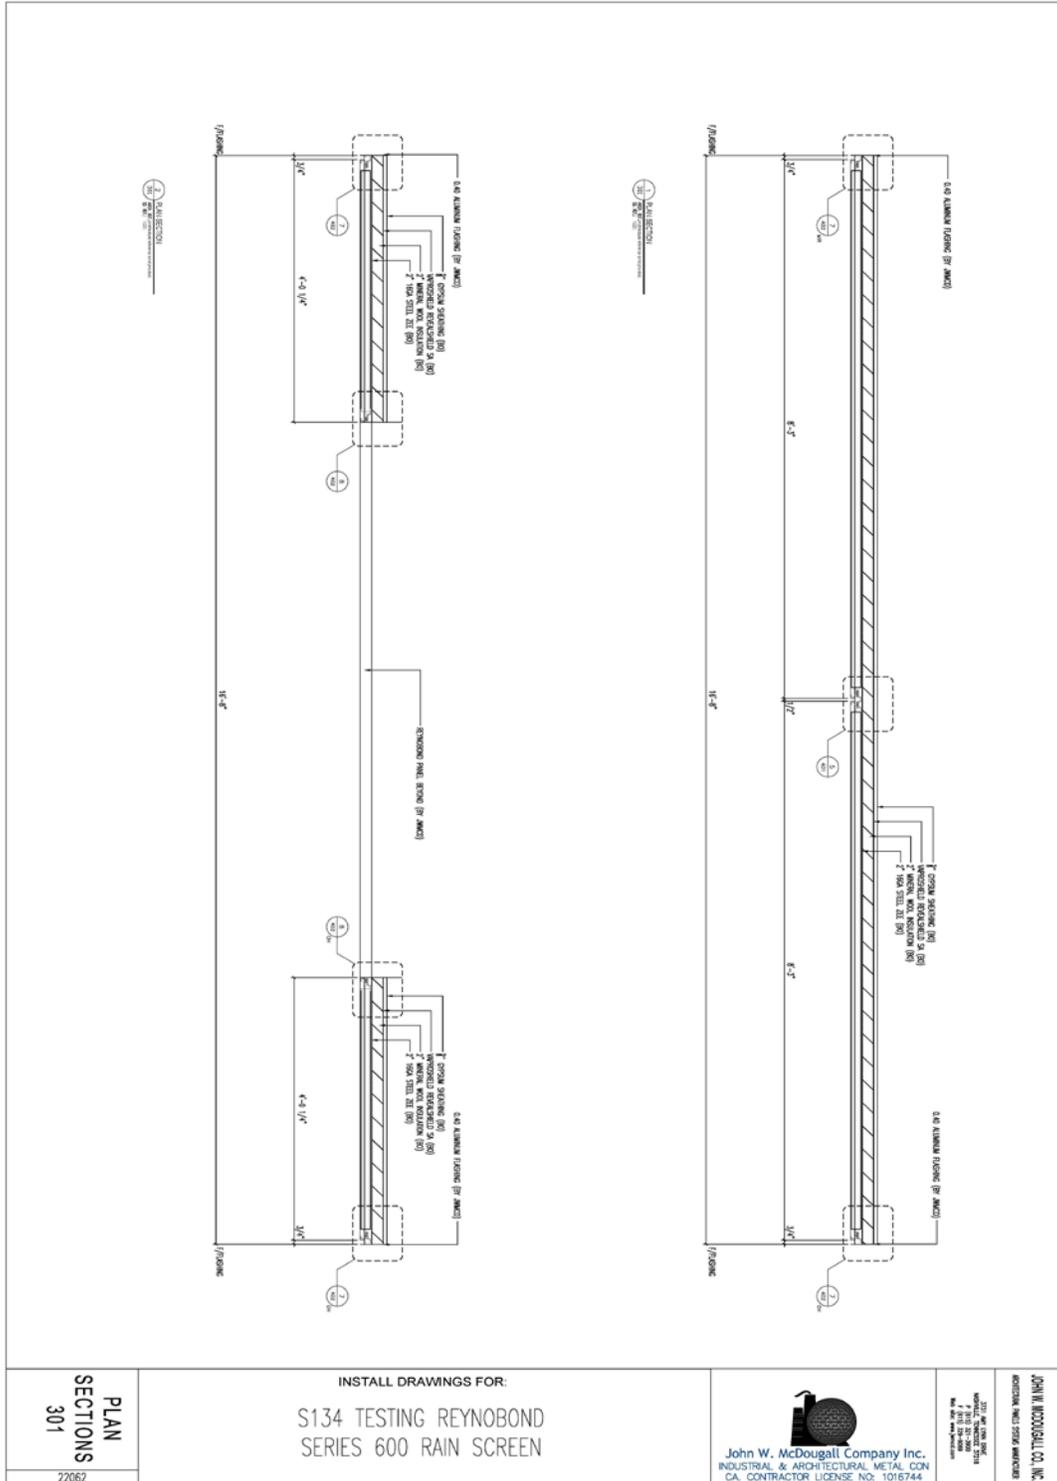
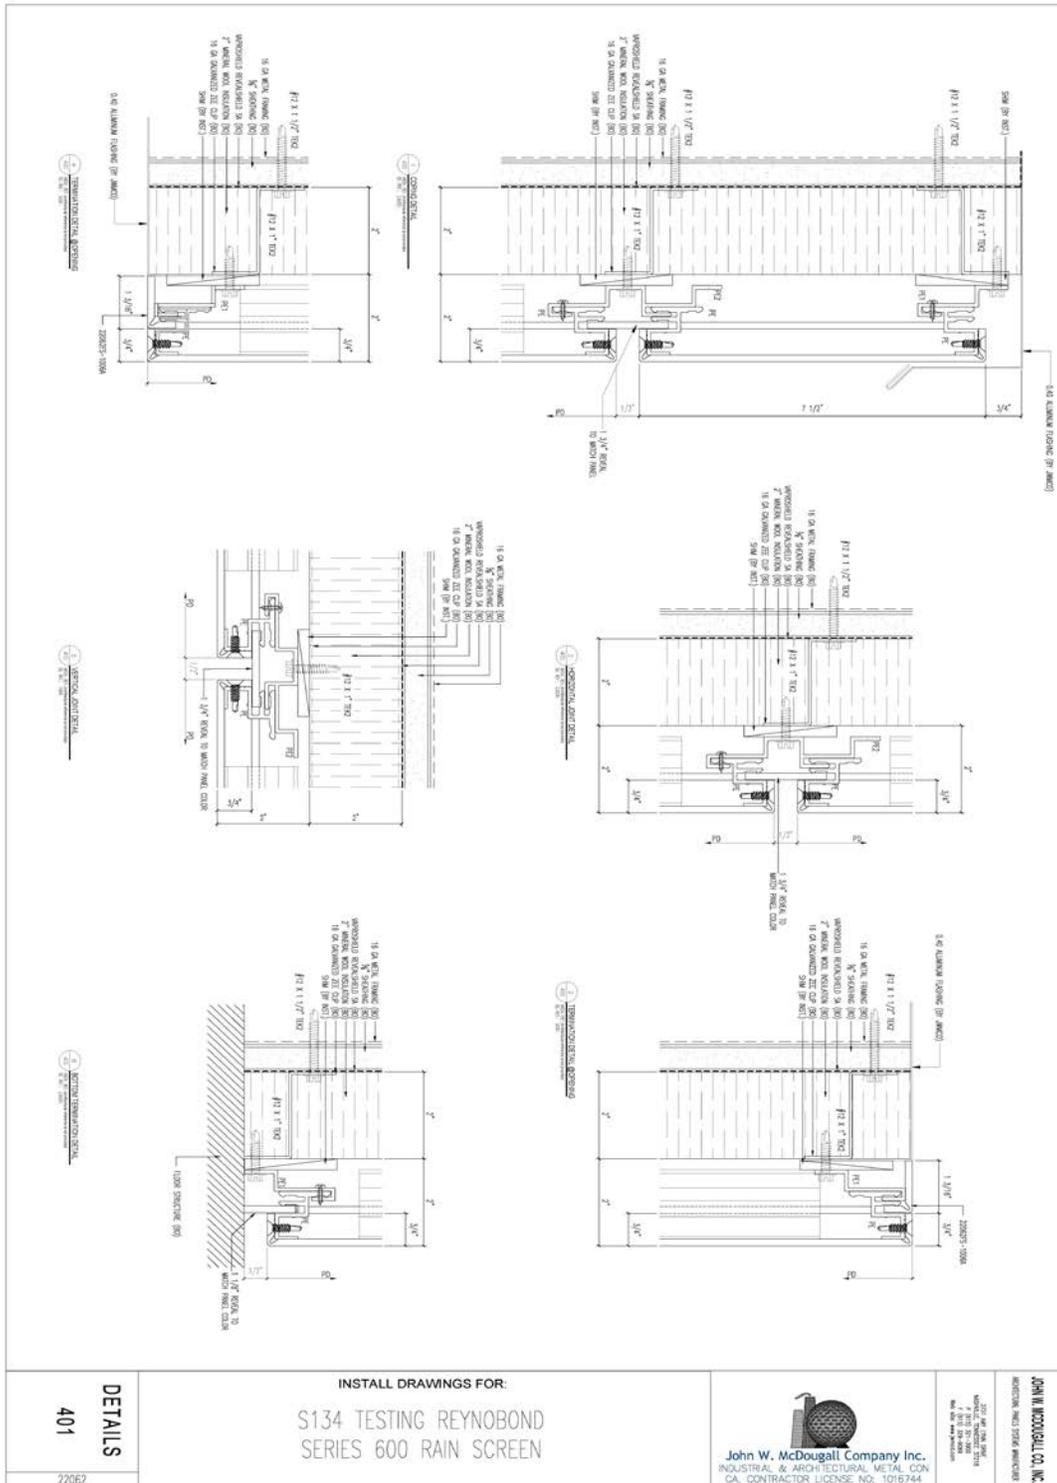
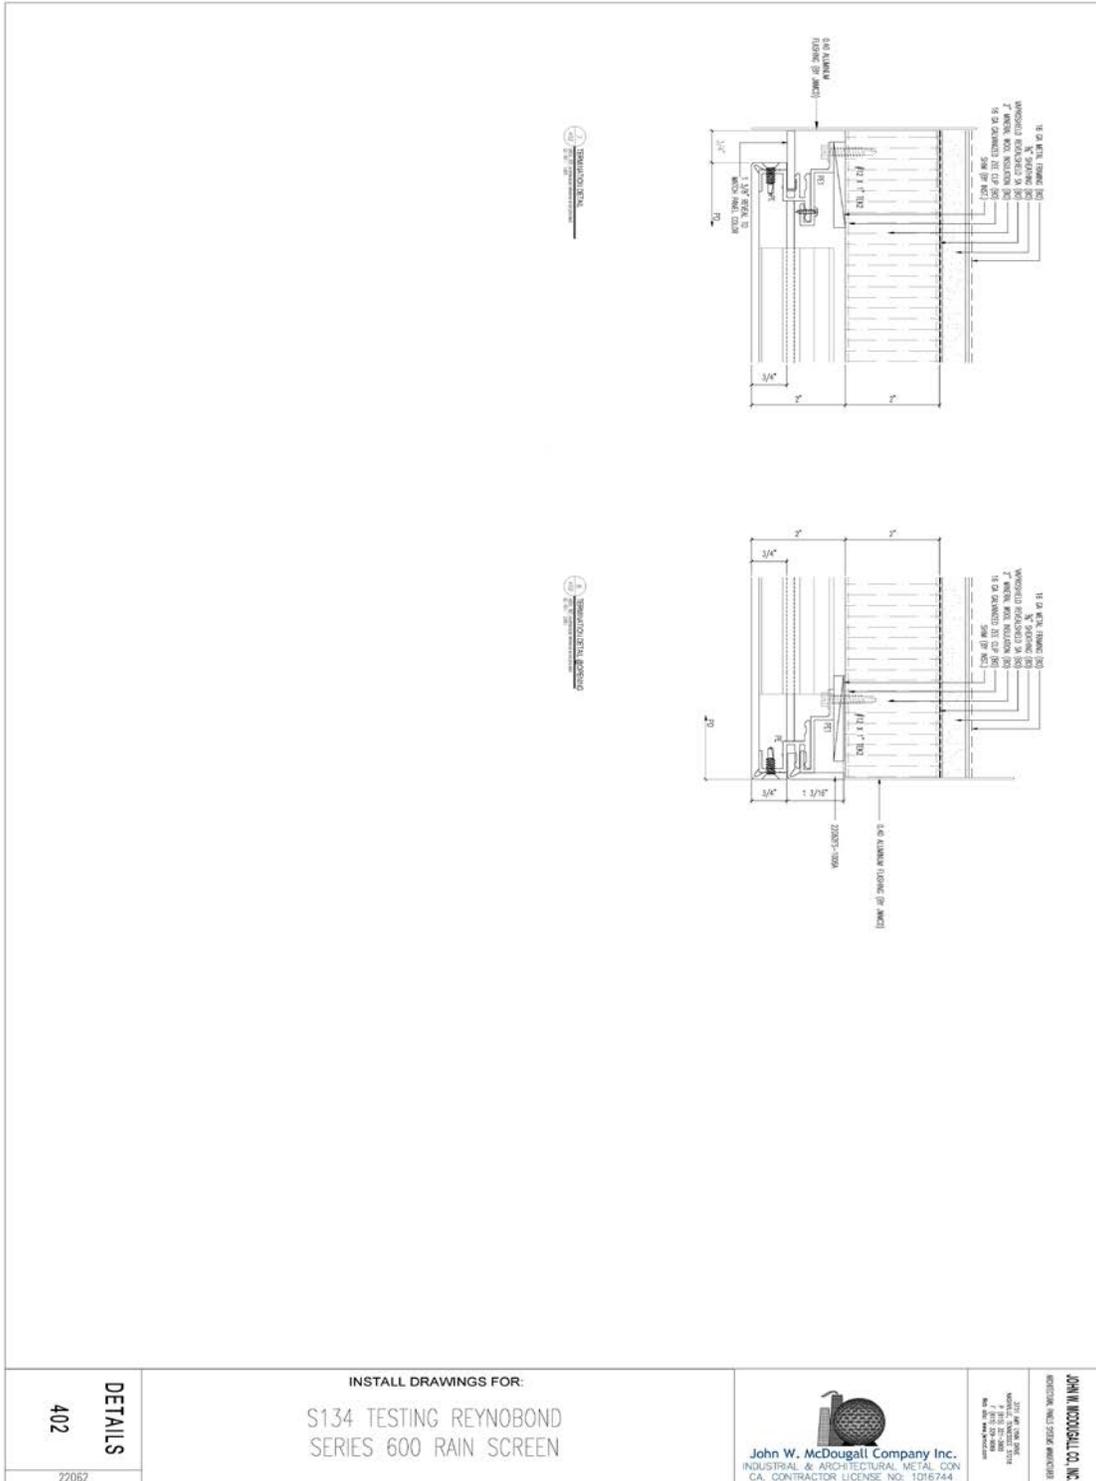
The "As-Built" drawings for the Reynobond Series 600 Rain Screen ACM System CAN/ULC S134 test; Sheet Nos. 1-5 and dated October 24, 2022; which follow have been reviewed by Intertek B&C and are representative of the project reported herein. Project construction was verified by Intertek B&C per the drawings included in this report. Any deviations are documented herein or on the drawings.

The concrete base wall was sheathed with one-layer of 1/2 in. thick gypsum sheathing.

VaproShield RevealFlashing SA® Self-Adhered vapor barrier was applied to the surface of the gypsum sheathing. 16GA, 2 in. galvanized zee girts were then installed to the weather barrier using 1/4" x 2-1/4" long concrete fasteners, spaced at nominal 12 in. oc. 2 in. mineral wool insulation was then installed between the zee clips, having a density of 4.3 pcf. The 4mm Reynobond series 600 ACM panels were installed to the zee girts using 3 in. wide aluminium extrusions clips, spaced at nominal 36 in. oc, attached using #14 x 2-1/2 in. self-drilling screws.

The window opening jambs, sill and header were lined with .040 in. thick aluminum flashing, width of 4 in. This flashing was also used to seal the sides and top of the wall assembly. The header was also lined with 26GA steel flashing, width of 14 in. with 1 in. thick 6 pcf ceramic fiber blanket.
