QC-10[®] MOLD MATERIAL

High Strength Aluminum for Production Injection Molds

ALCOA MOLD & TOOLING
TECHNICAL FACT SHEET

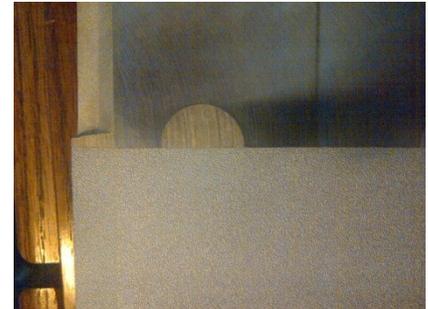
Figure 1. Cold spray demonstrated for dimensional restoration of QC-10[®] High Strength Aluminum Mold plate (1" diameter repair in the center; Edge / Corner repair in the lower left of the sample). Bottom half of the plate has been textured after cold spray repair (color match achieved for potential for cosmetic repair).

The Alcoa teams, in conjunction with various outside sources, have successfully demonstrated the use of cold spray technology for the repair of QC-10[®] High Strength Injection molds. Significant trials have been conducted utilizing coupons made from scraped QC-10[®] injection mold pieces. Additionally, cosmetic repairs on Automotive Textures have been achieved by utilizing Cold Spray repair technology and re-texturing the repaired area.

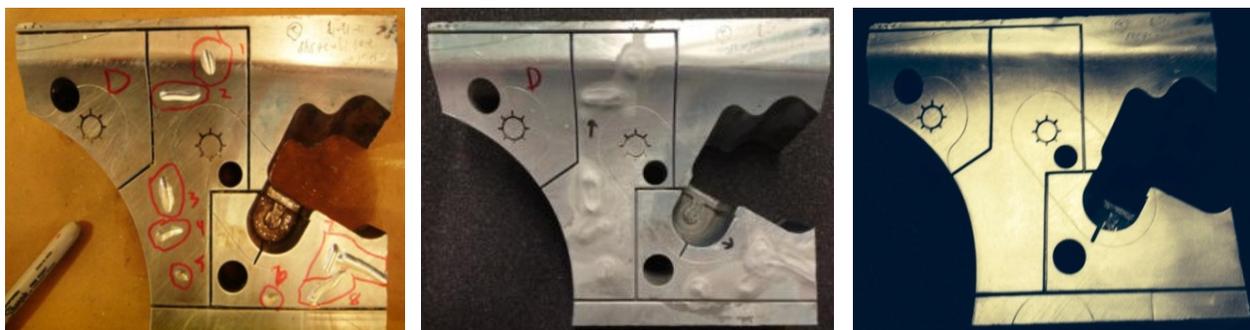
Figure 2. Left – QC-10[®] mold piece with various damages; Middle – Cold spray repaired mold piece; Right – After surface finish.
